Subject: HEADER WEATHERSTRIP - BUTYL ADHESIVE ISSUES	Bulletin No: 09-001/06
	Last Issued: 1/26/2006

2006 MX-5

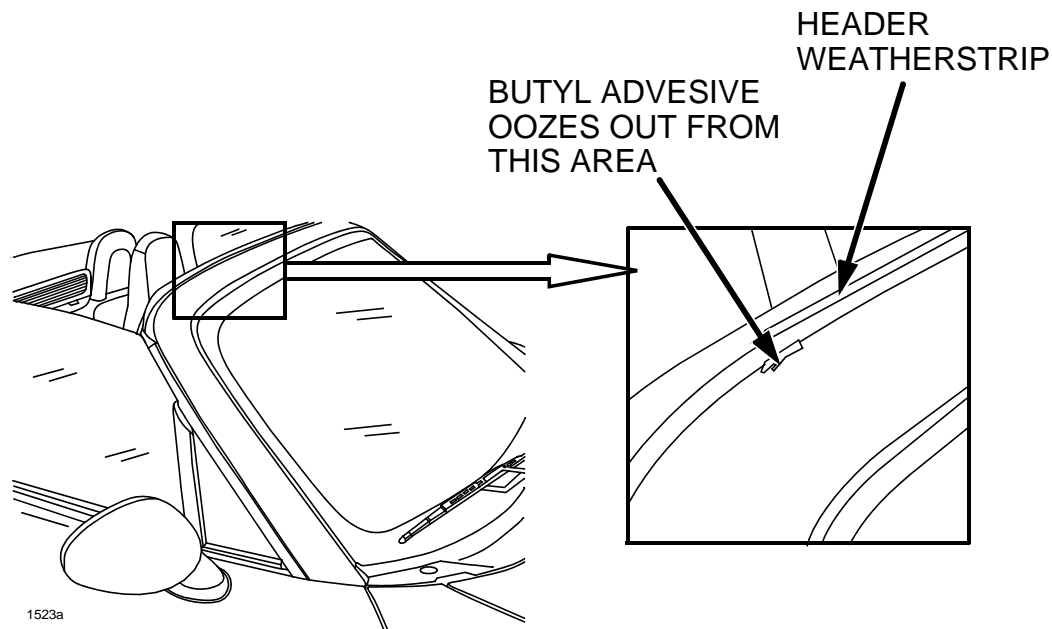
Butyl Adhesive Oozing From Header Weather-Strip

As the convertible top is used, the header weather-strip gets compacted. This causes excess butyl adhesive to be pushed out of the header weather-strip and onto the painted surface. As a production change, the process of butyl adhesive application has been modified during assembly.

Customers having this concern should have their vehicle repaired using REPAIR PROCEDURE A - BUTYL ADHESIVE OOZING FROM HEADER WEATHER-STRIP.

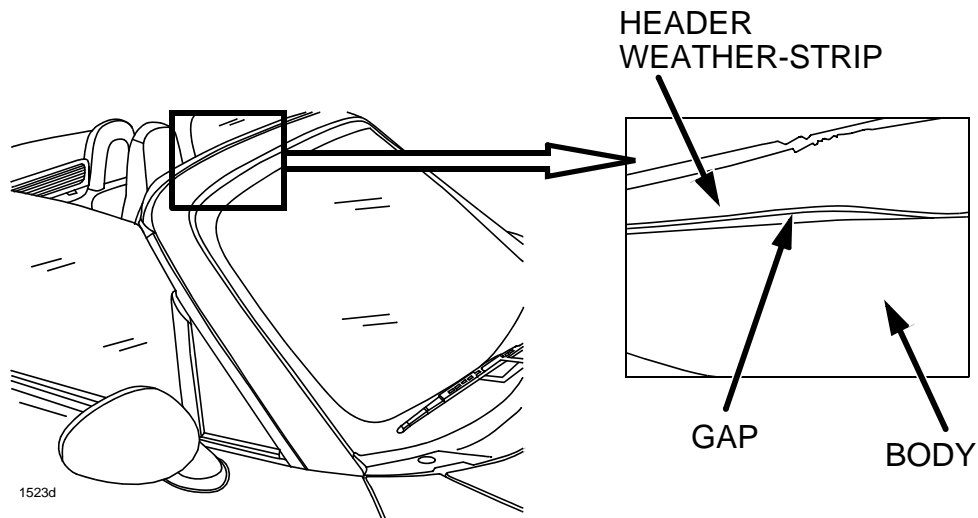
Gap Between Header Weather-Strip And Body

On some vehicles, the waterproofing butyl adhesive inside the header weather-strip is unevenly applied. As a production change, the process of butyl adhesive application has been modified, and a pad has been added inside the header weather-strip to prevent this condition.

Customers having this concern should have their vehicle repaired using REPAIR PROCEDURE B - GAP BETWEEN HEADER WEATHER-STRIP AND BODY.

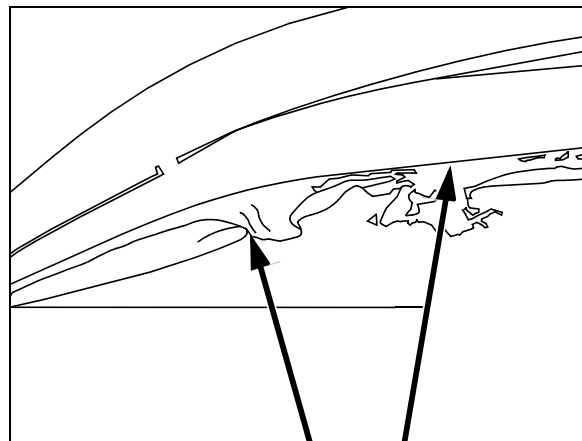
1523f

UNEVEN BUTYL ADHESIVE

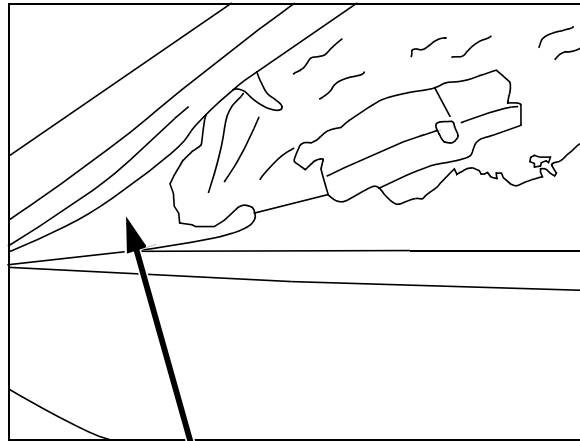
1523g

**EVEN BUTYL
ADHESIVE**
