Subject: CENTER CONSOLE LID WILL NOT STAY CLOSED	Bulletin No: 09-033/06
	Last Issued: 7/21/2006

2006 MX-5

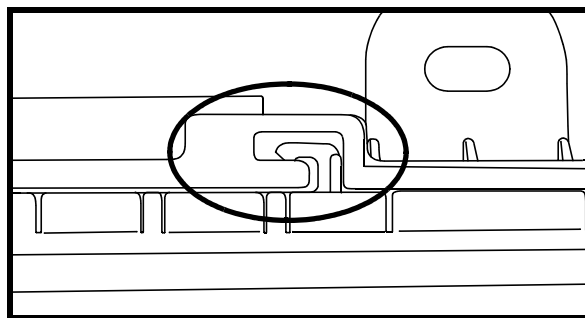
GUIDE TAB SHOWN DISENGAGED

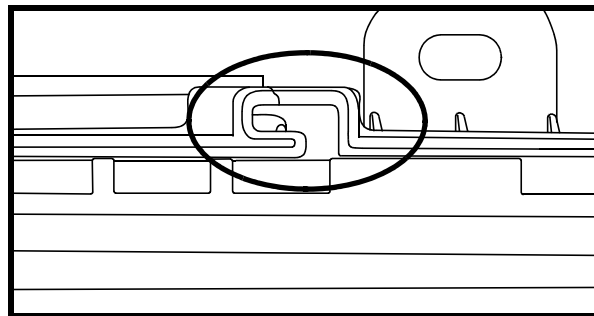
1653h GUIDE TAB SHOWN ENGAGED
