Technical Service Bulletin

Subject: OIL LEAKAGE FROM DRIVE BELT AUTO TENSIONER AND RATTLE NOISE FROM ENGINE COMPARTMENT	Bulletin No.: 01-019/19
	Last Issued: 11/26/2019

Bulletin No.: 01-019/19	Last Issued: 11/26/2019

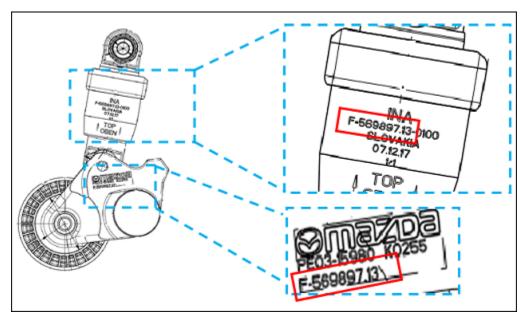
Example:

Part Number	Description	Qty.	Note
PET2-15-980 Tensioner-Auto		New modified drive belt auto tensioner can be identified by	
		serial number F569897.<u>13</u>. Refer to the example below.

NOTE: The last two digits of the serial are different between the old and new parts.

- New part serial number is **F569897.13**.
- Old part serial number is **F569897.10**.
