# 99-05 Mazda Miata Tension Cable Replacement

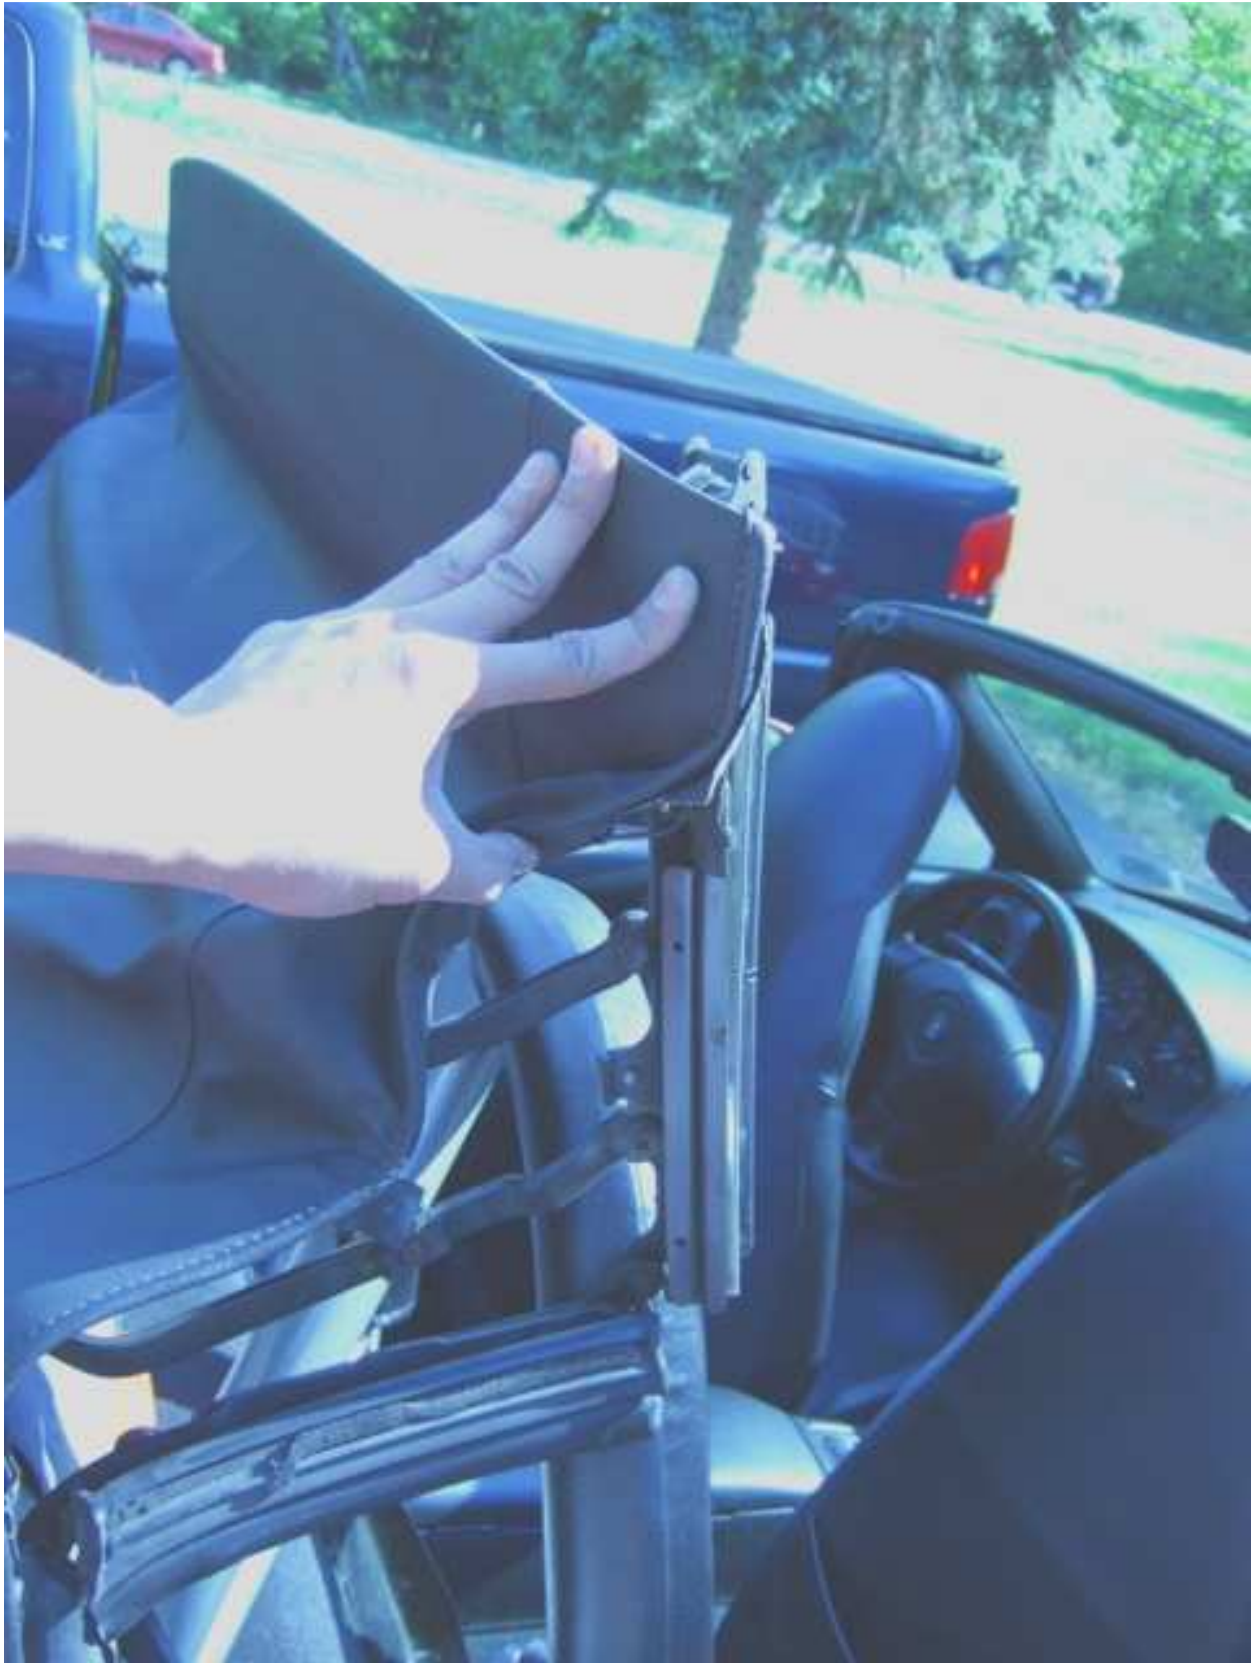
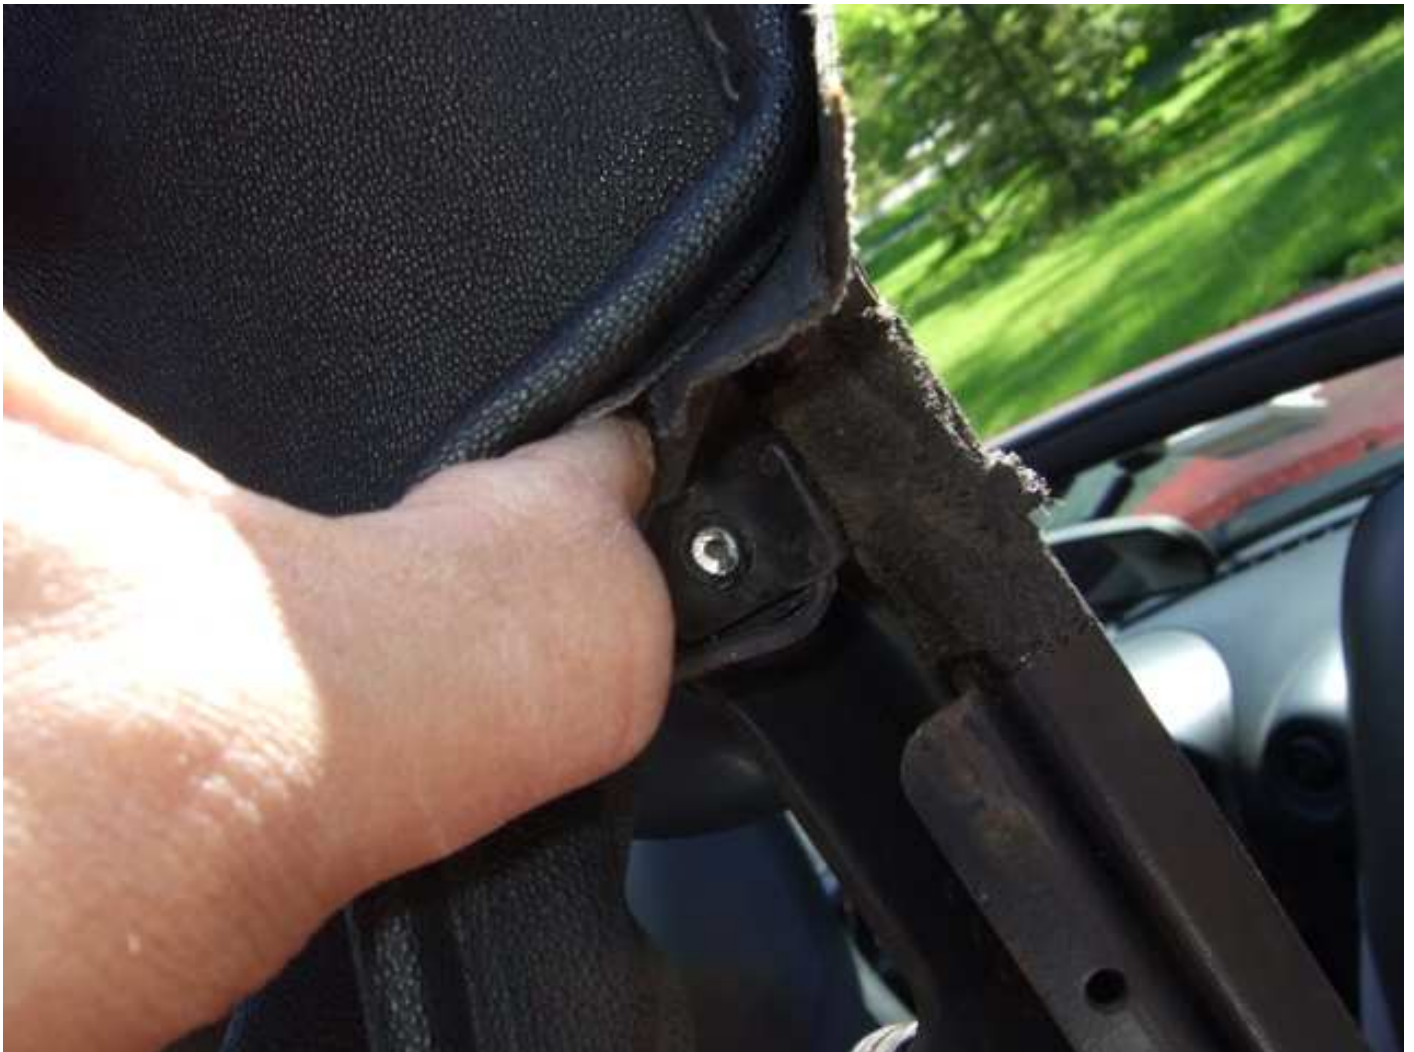
13/64" drill bit to remove the head.

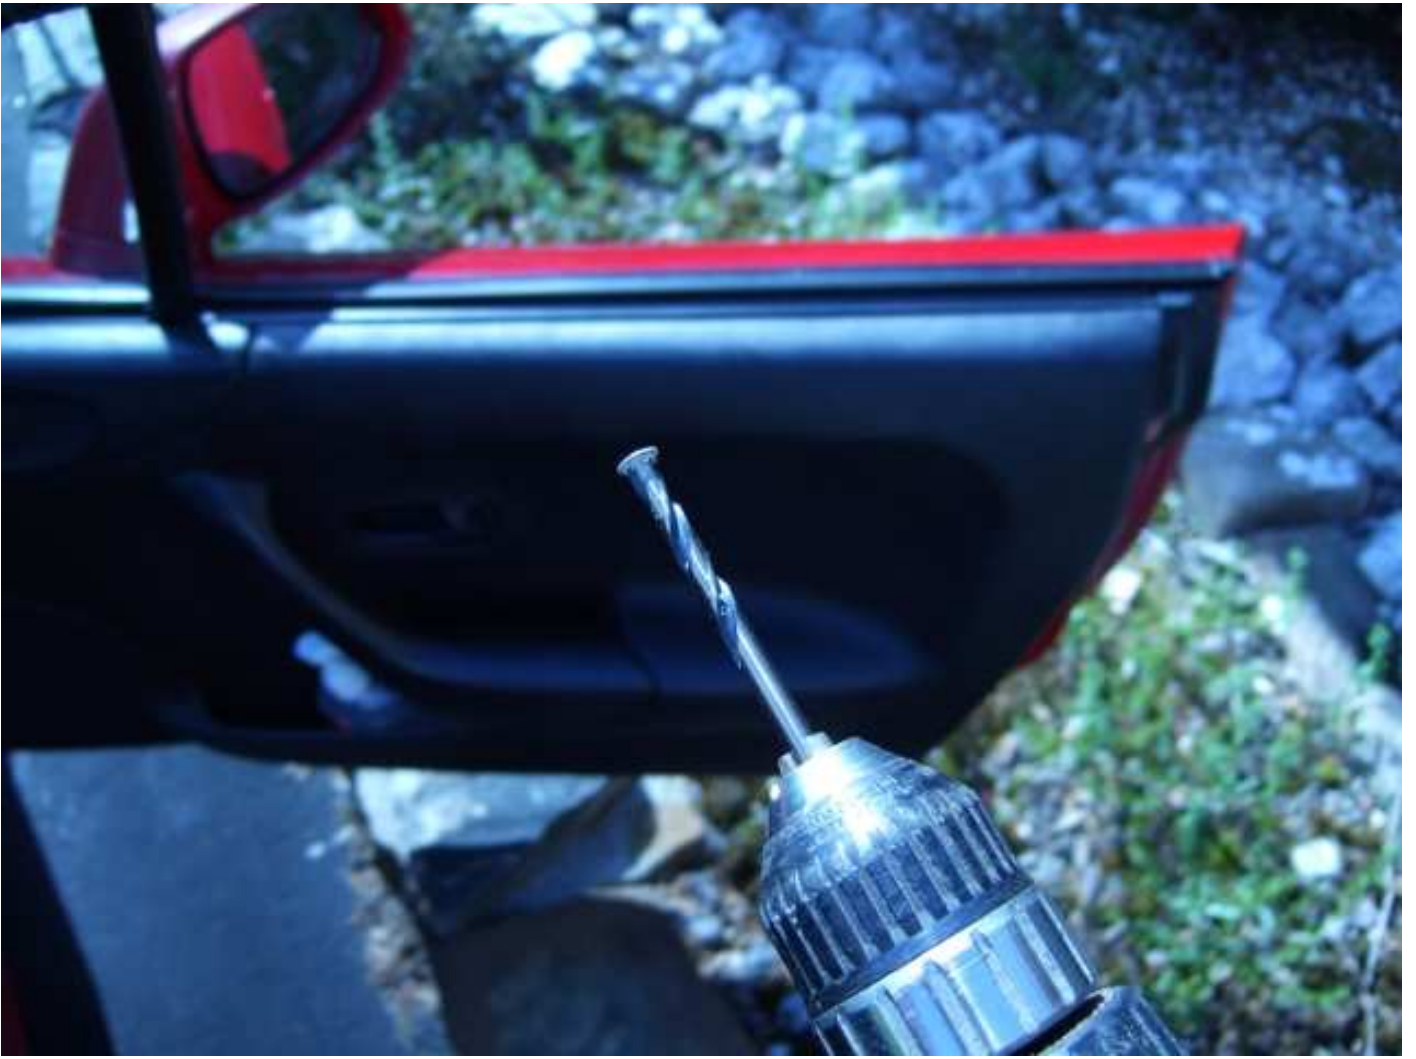
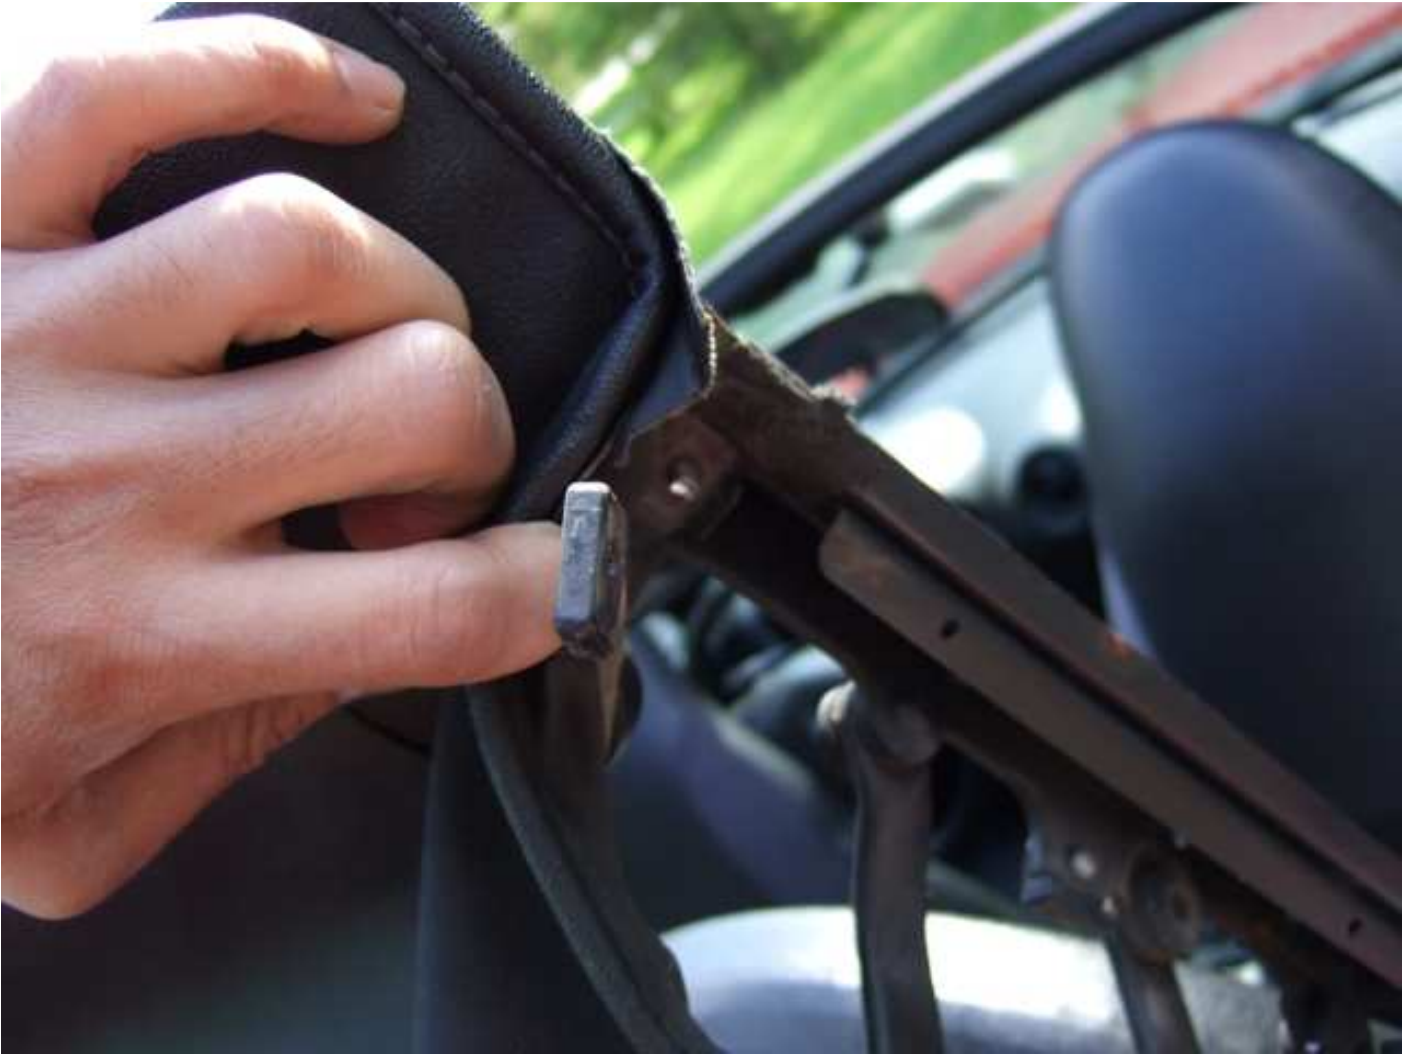
Proceed with the 5/32" bit to remove/free up the remainder of the rivet. The "flag end" should come loose and release tension on the spring end of the cable.

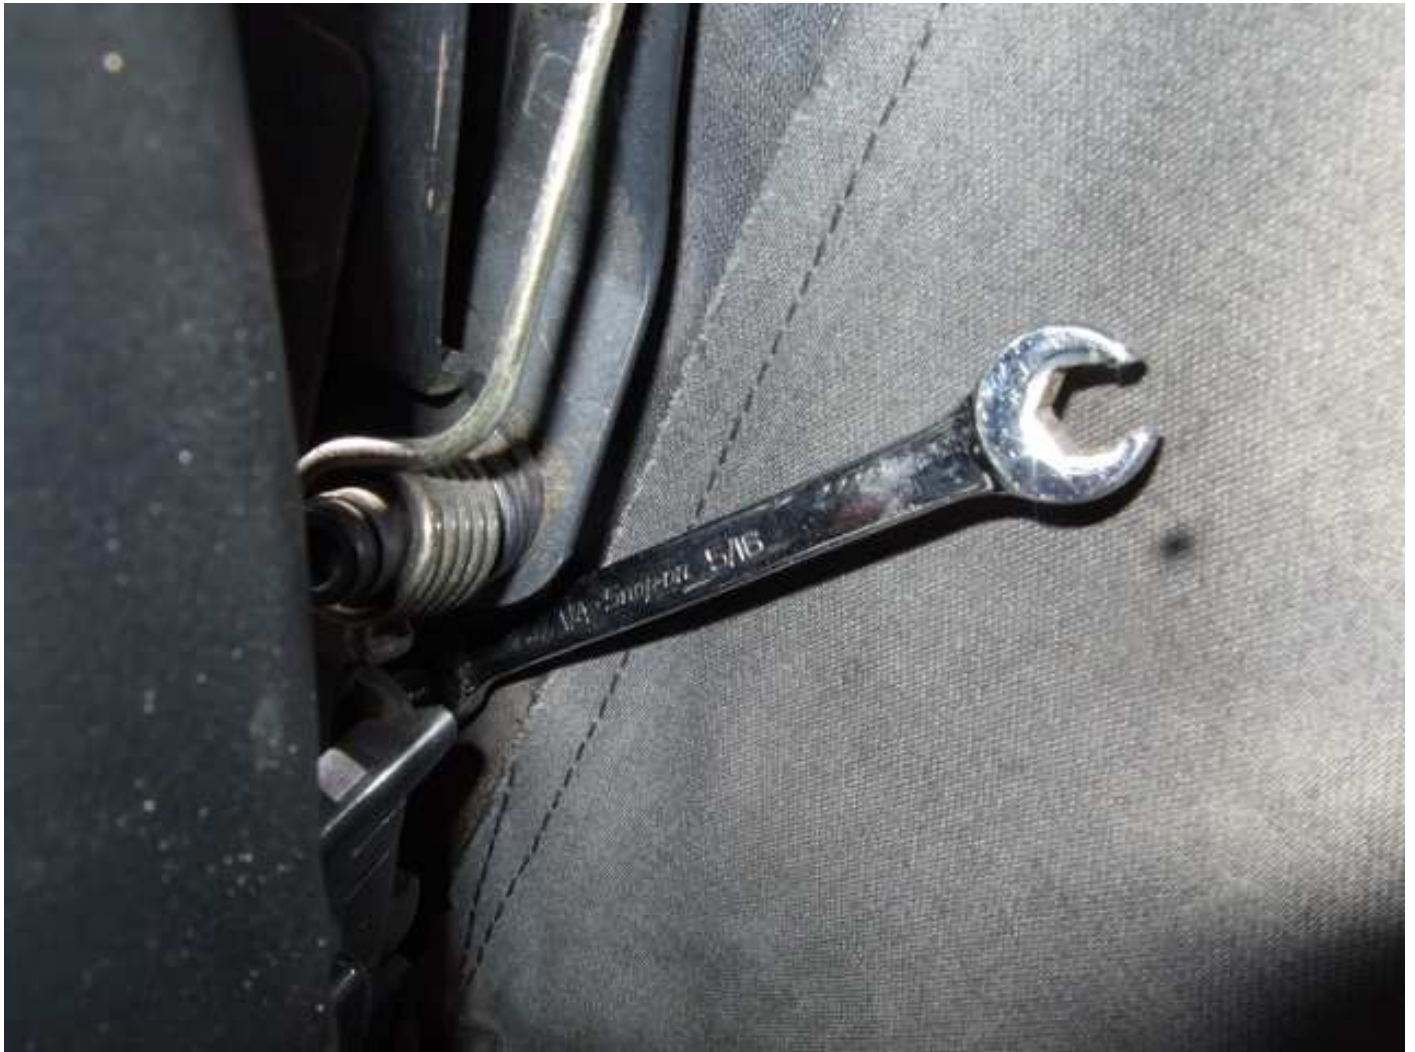
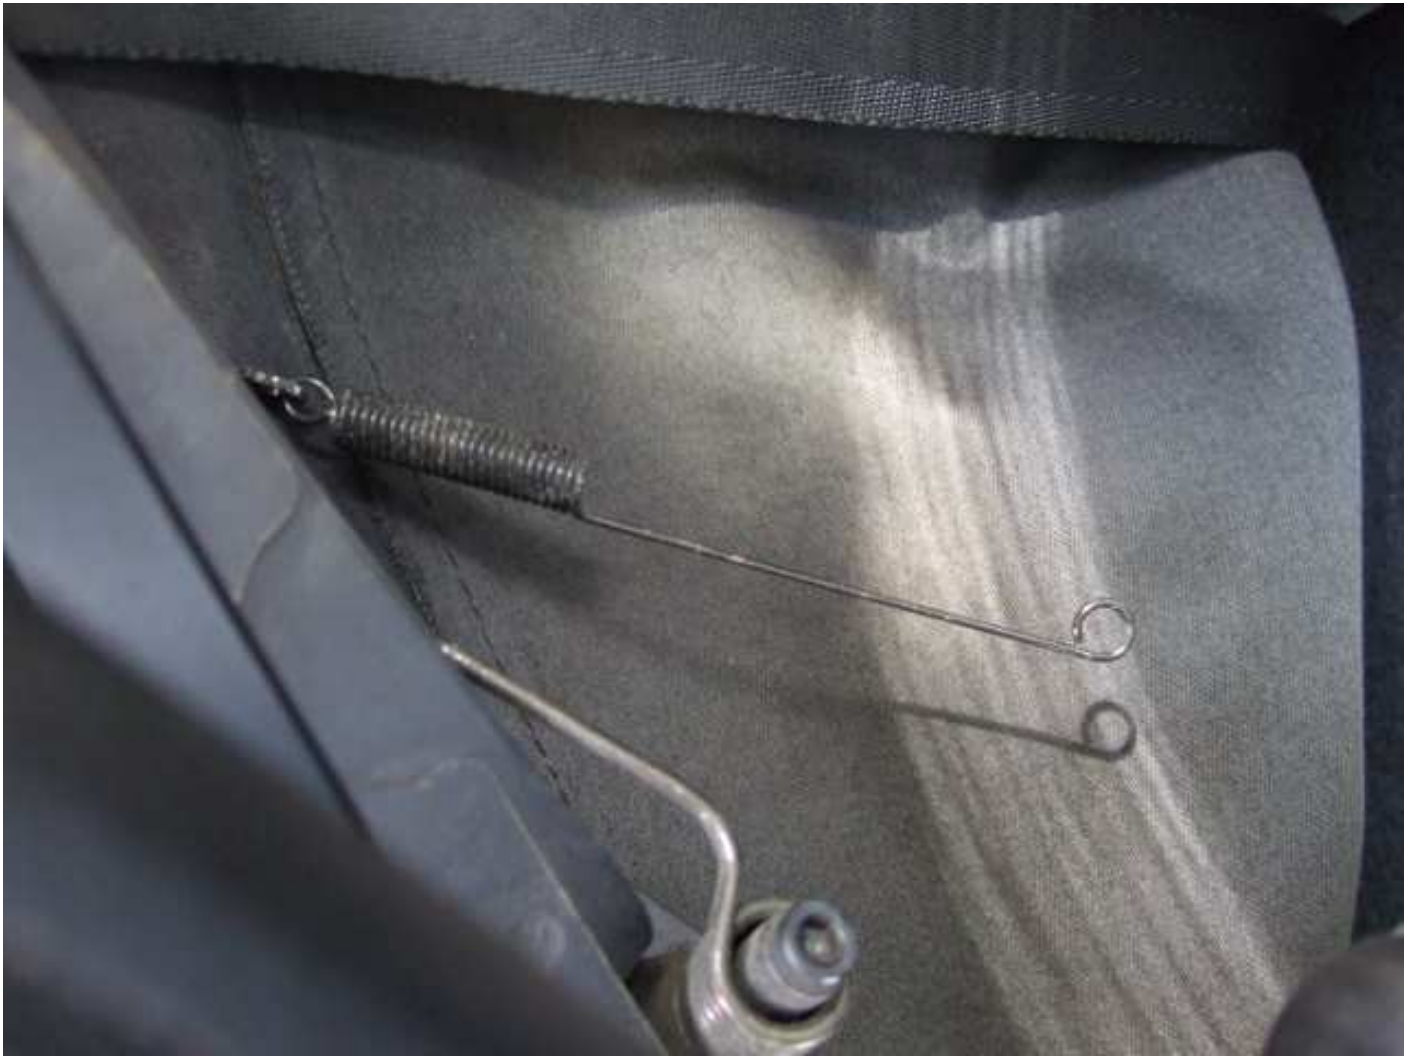
Return to the spring end and remove the Philips head bolt using the appropriate tool.

You can disconnect the spring from the lug of the cable. I found it easier to use a small pair of vice grips to do so. Pliers could work, too.

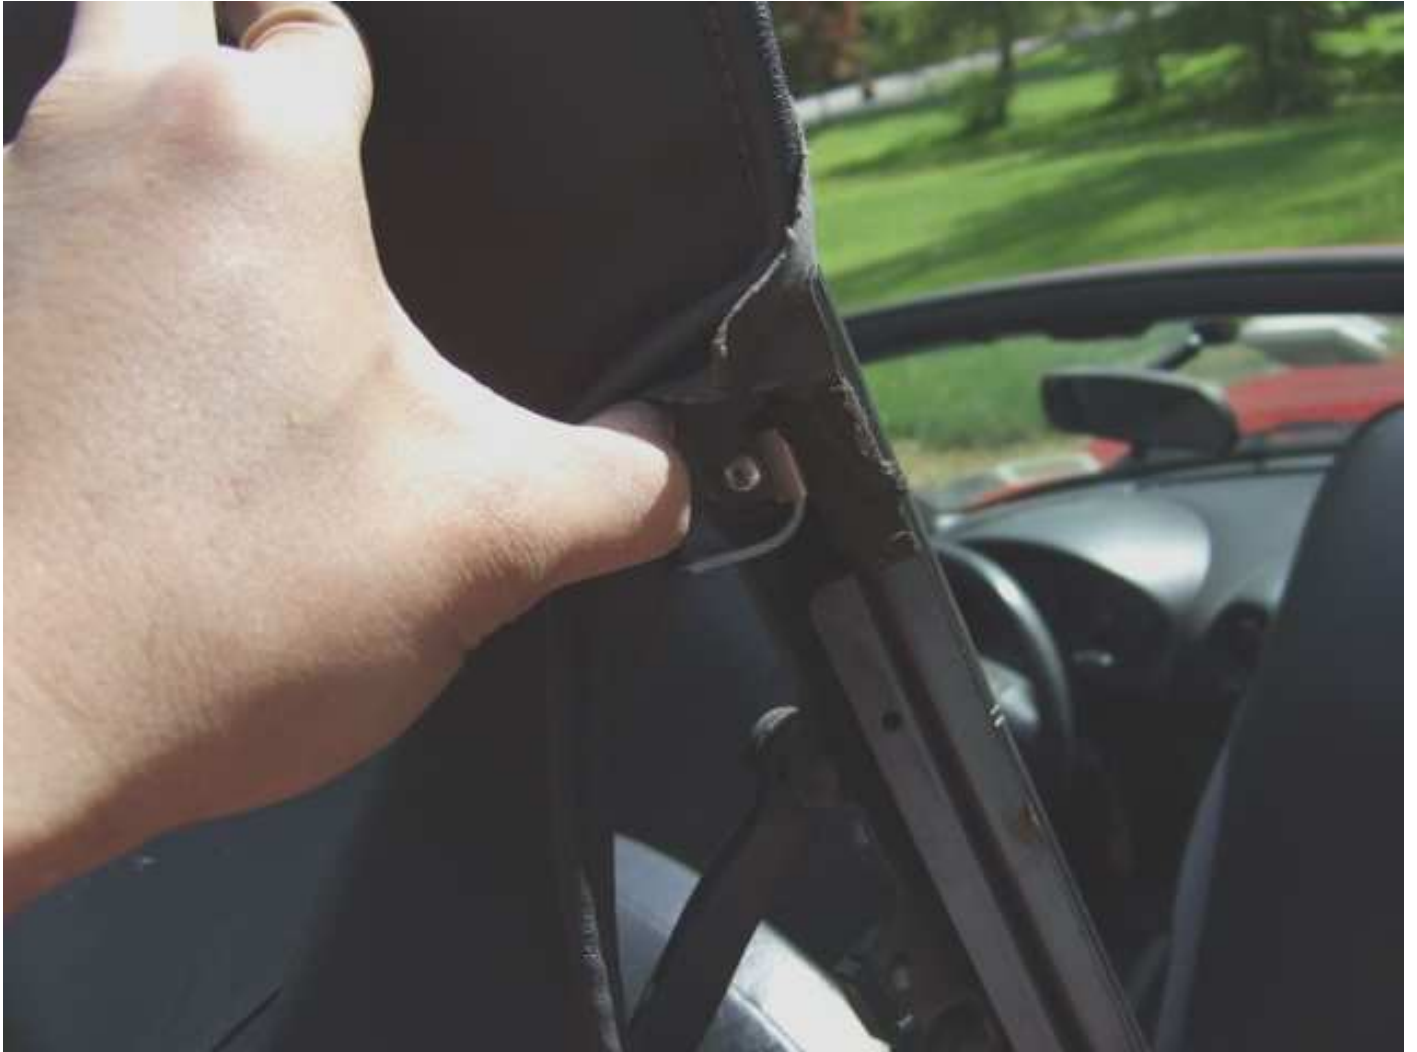
Next, pop a new rivet in. I did so with the “flat side” of the flag against the frame.

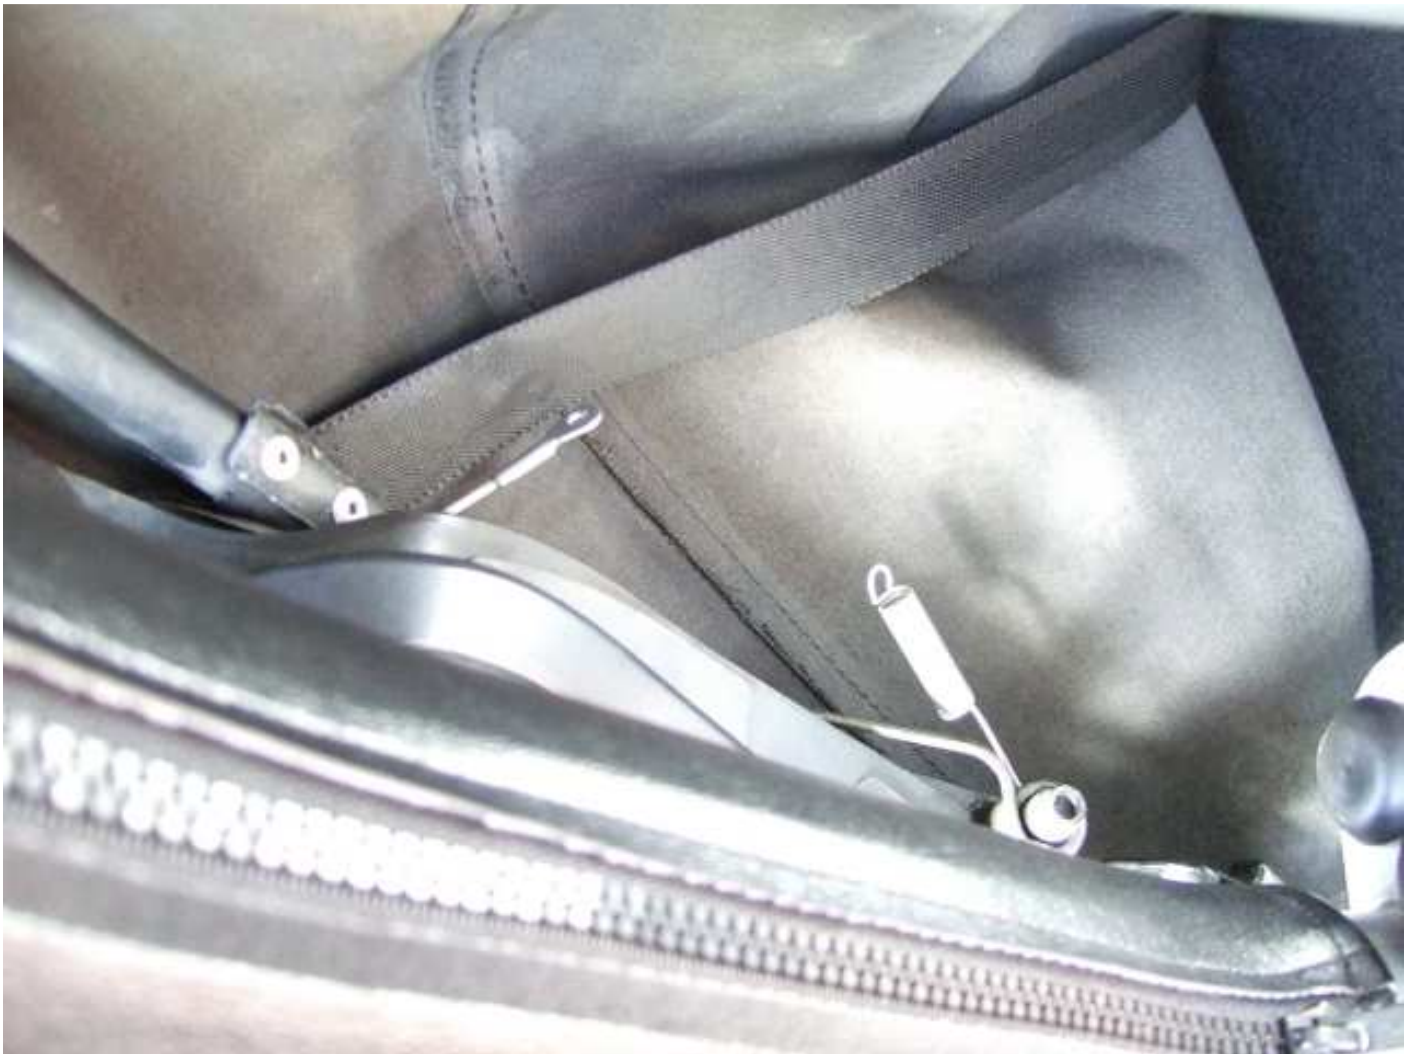
If you chose to reuse the factory Philips head bolt, good for you. I used the bolt I mentioned earlier with said washer, tightening with a ratcheting box end wrench.

There isn't much else to explain after this. Reconnect the spring to the lug of the tension cable. Again, some rocking of the top up and down is necessary to find the position of least tension, bringing the lug and spring closer together. The small vice grips helps in pulling the spring up to the lug. The remainder is reassembly of the weather stripping components (reverse of the disassembly).
