Mazda Miata window guide replacement for NBs with electric windows

This procedure was written to supplement the window guide supplier's procedure, not replace it.

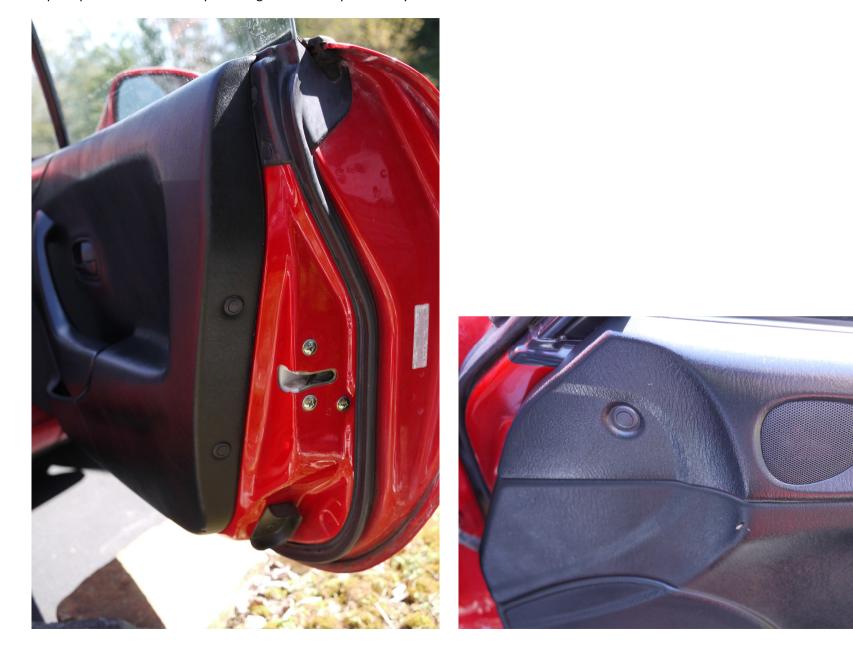
There are three (3) push type door trim clips. 2 located at the rear of the door trim and one (1) forward near the tweeter. A small flat bladed screwdriver is used to pull up the center of the clip allowing the whole clip to be fully removed.

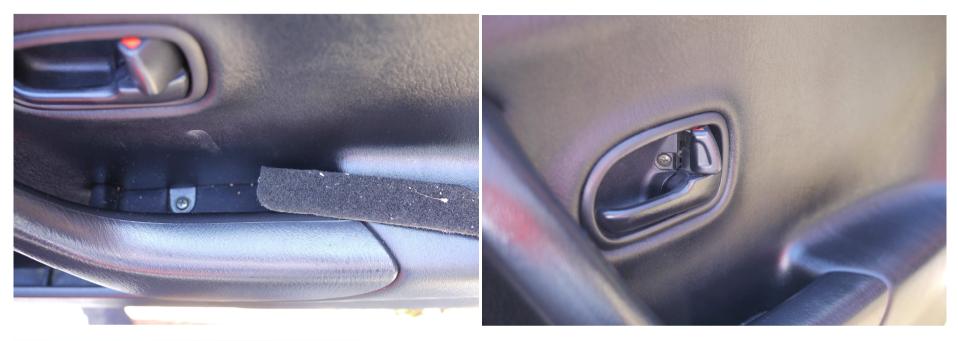
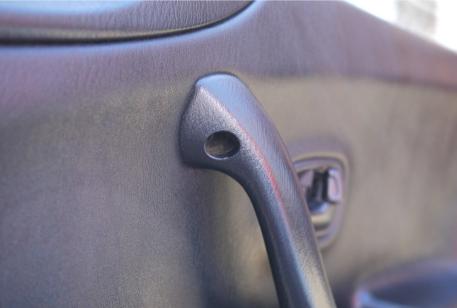
There are three (3) Philips head screws that need to be removed as well.

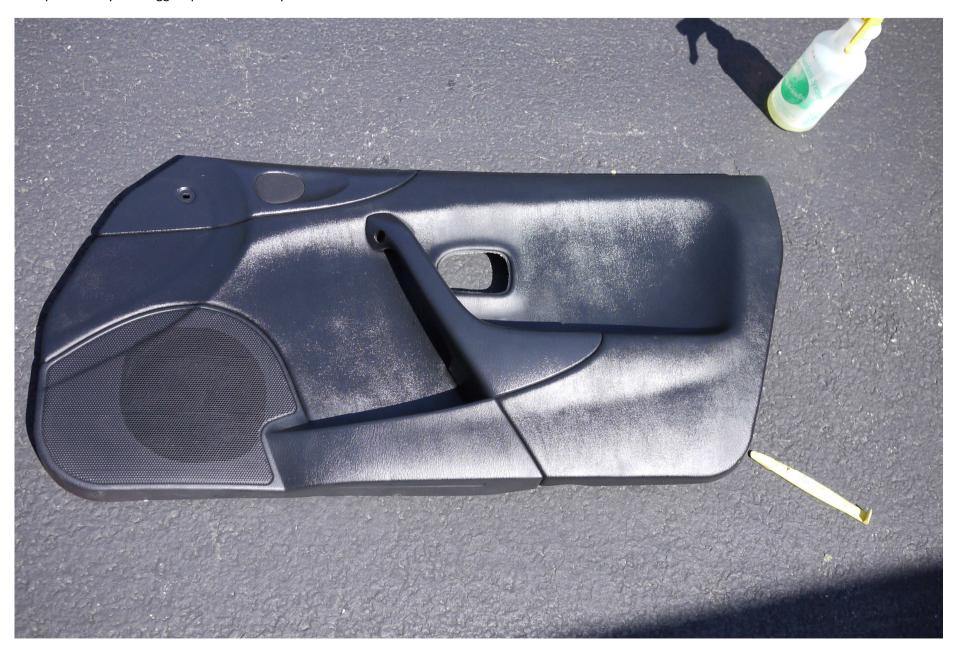
Insert a nylon pry bar between the door panel and door about the perimeter. Take care of the speaker. When the door panel is loose, grasp the pull of the inner door panel firmly and wiggle up. Set the door panel aside.

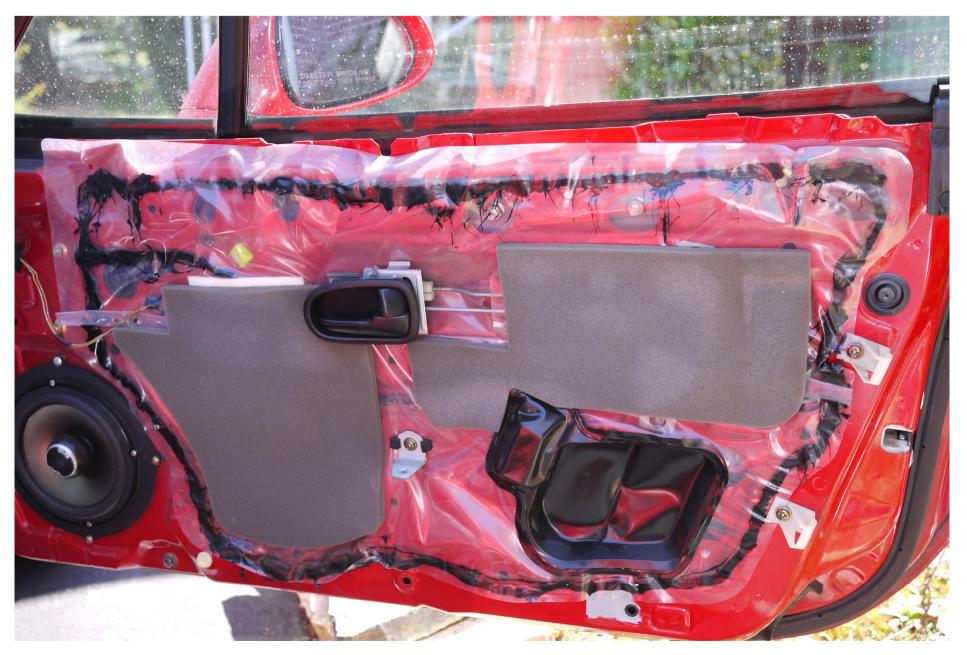
The door should look like this:

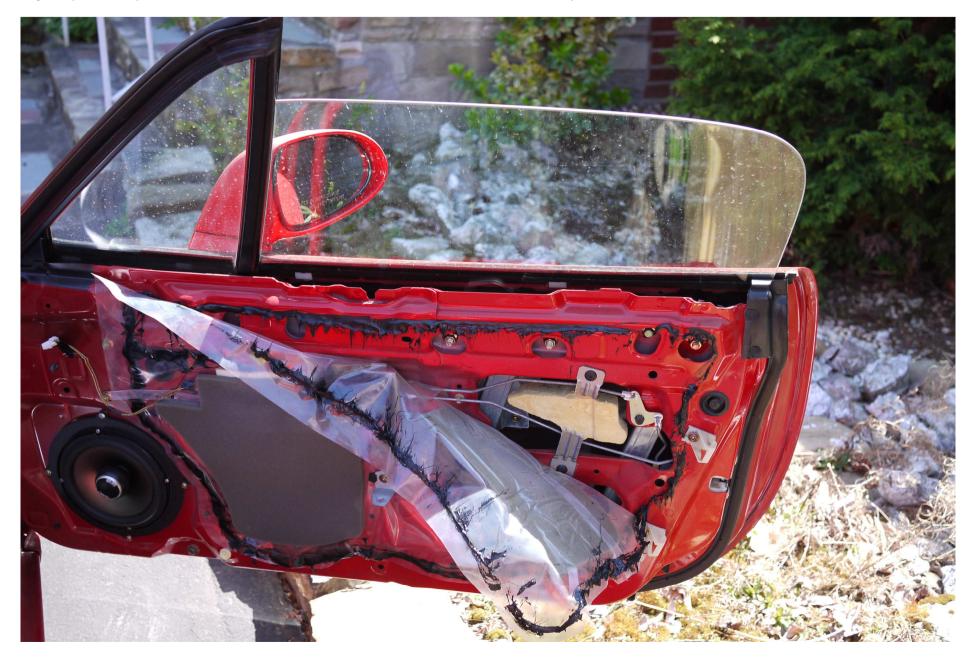
Begin to peel the vapor barrier back like so and lower the window down. Take note of window position.

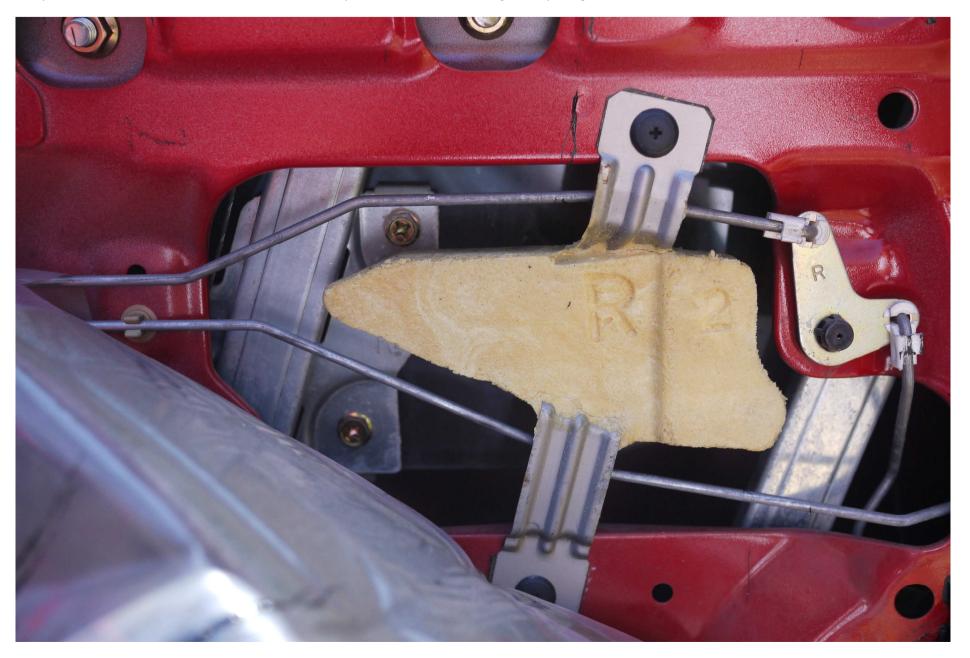
This permits 2 of the 3 screws which hold the window in place to be removed through the opening of the door.

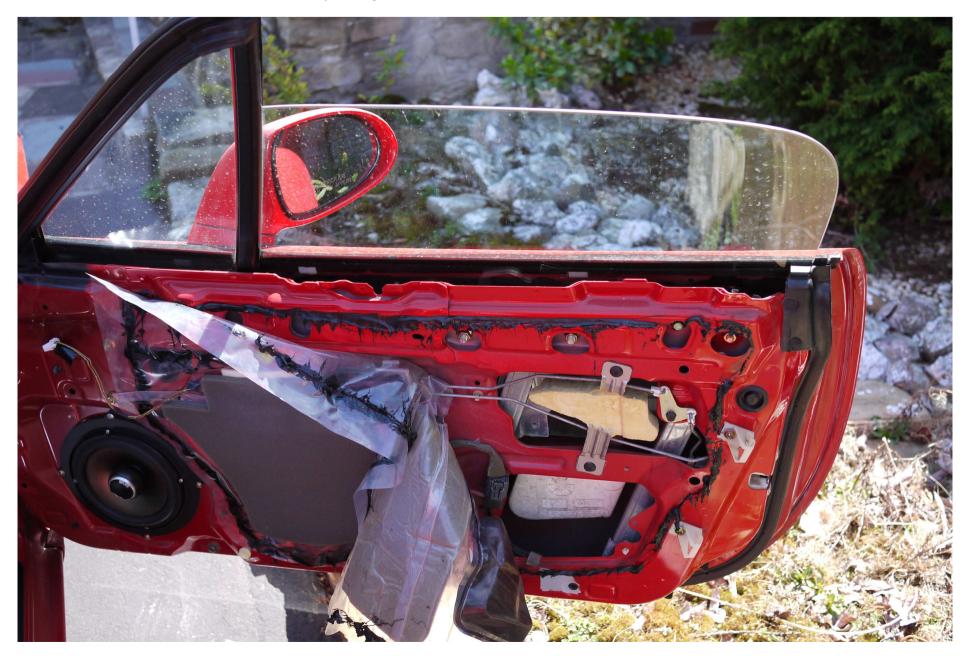
In order to obtain access, the window needs to be adjusted again to about here:

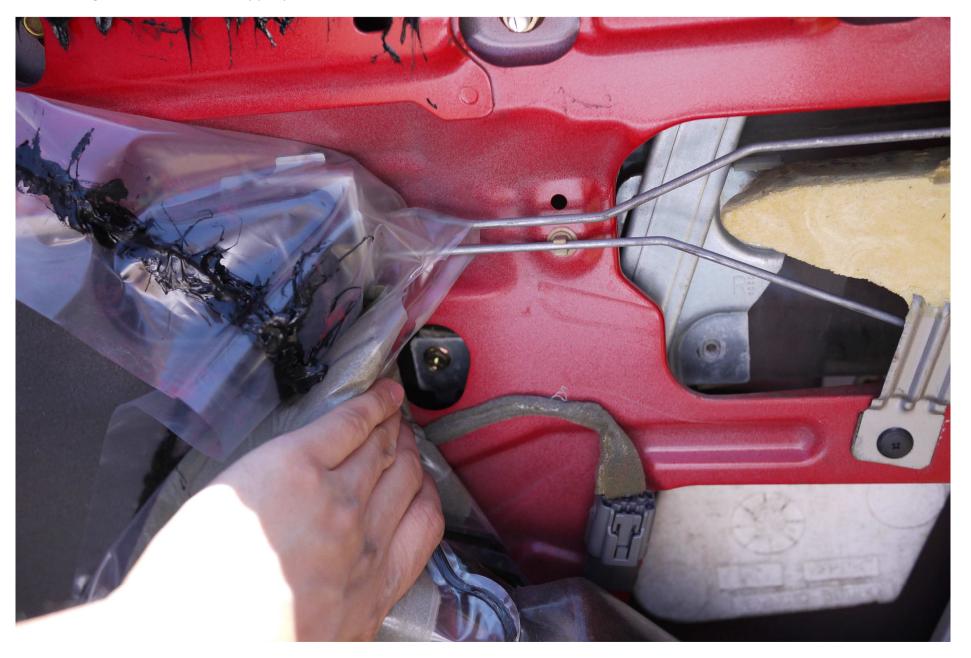
The remaining screw is here (towards my pinky):

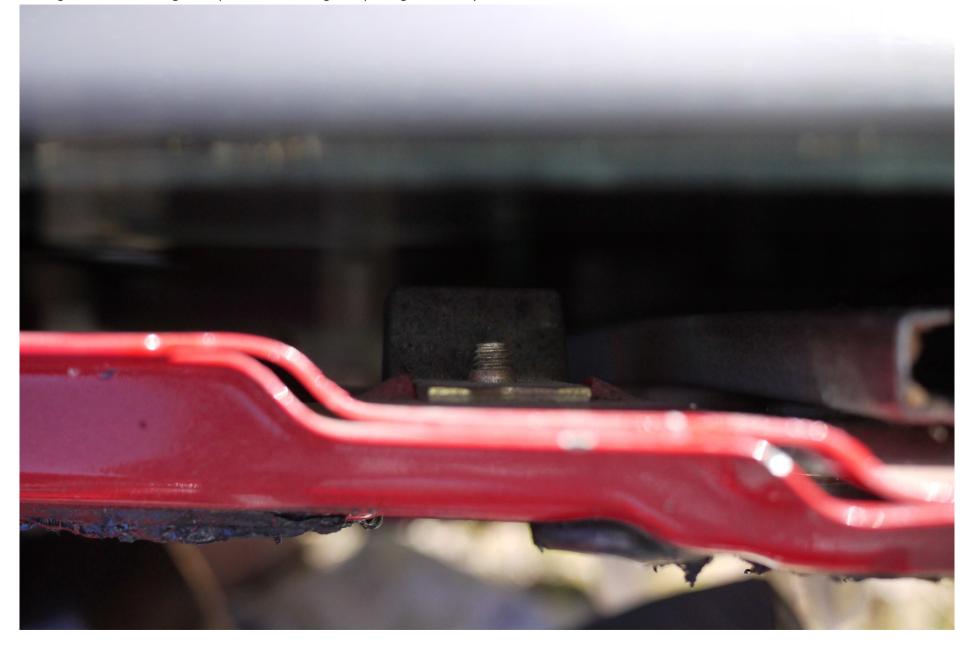
There are also upper window stops that prevent removal of the glass from the door and need to be removed. They dictate when the window stops when closed. I found there were two on the passenger side but only one on the driver side. This procedure covers the passenger side. Slip your fingers alongside of the interior of the glass when removing to keep them from falling and spinning free as they are threaded.

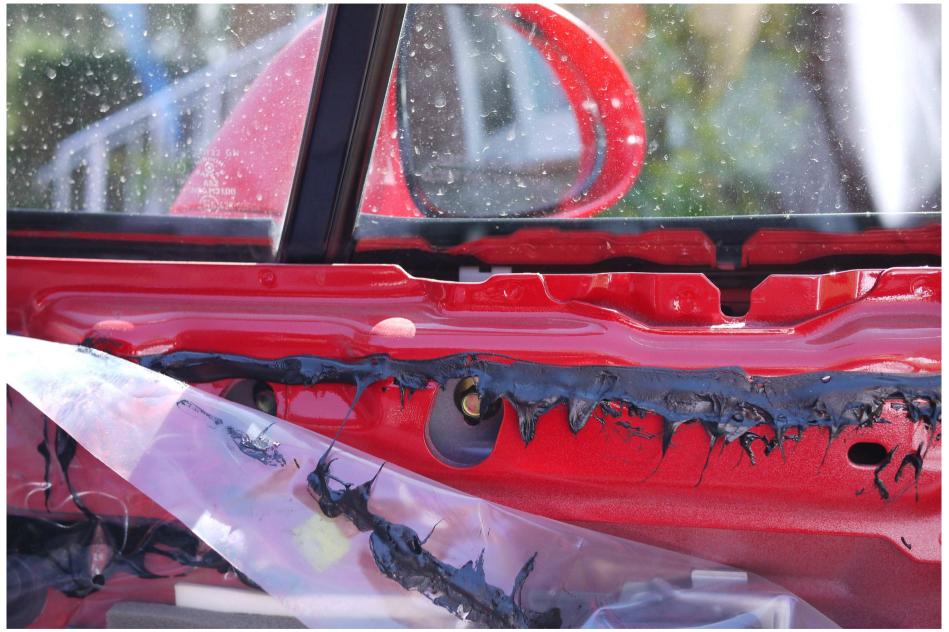
Here is the forward one:

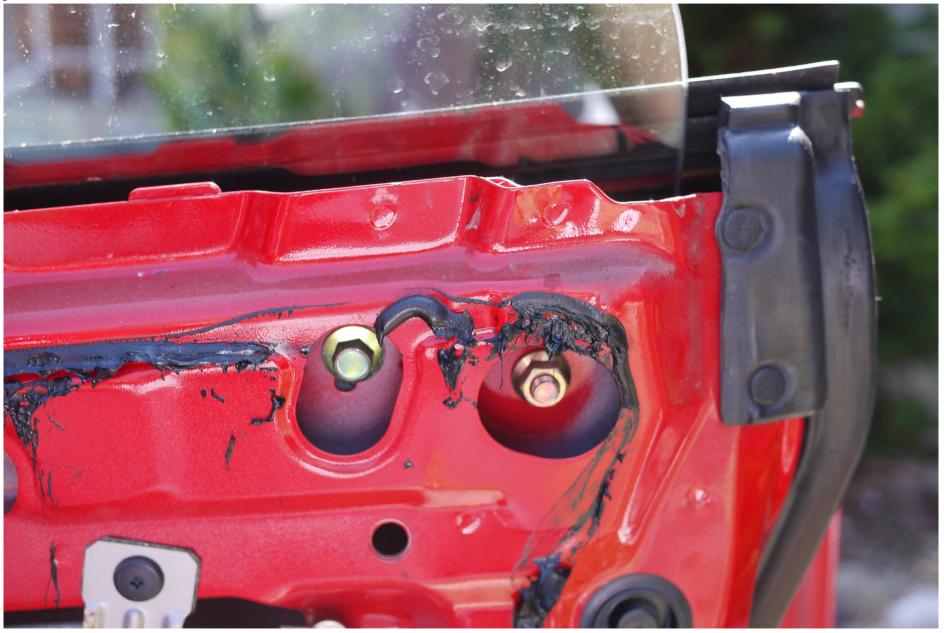
Here is the one aft (the screw not the nut):

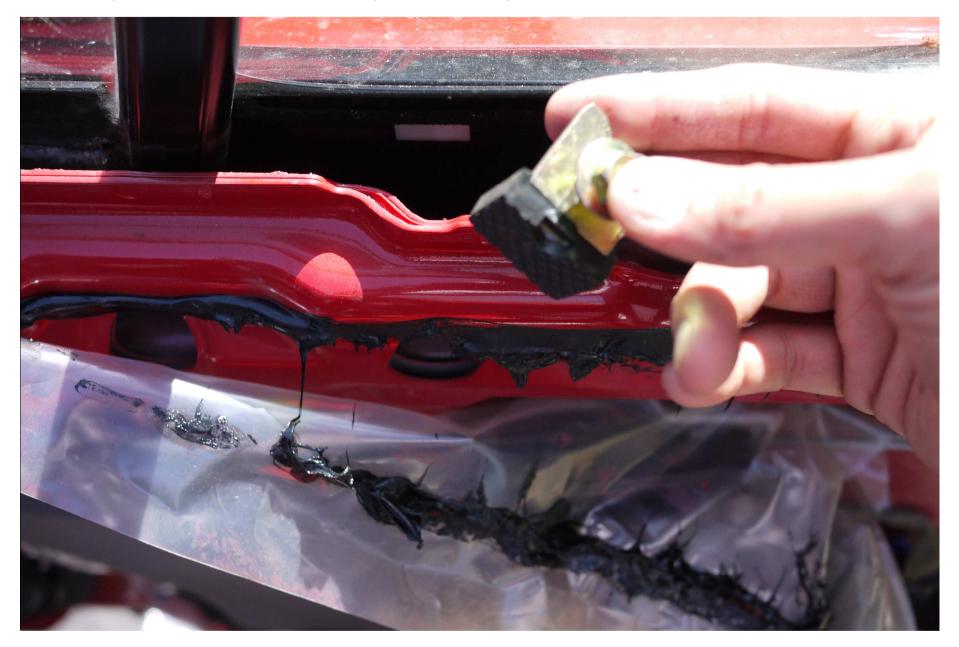
This is what they look like (I reinserted the bolt into the L shaped foot that is the stop):

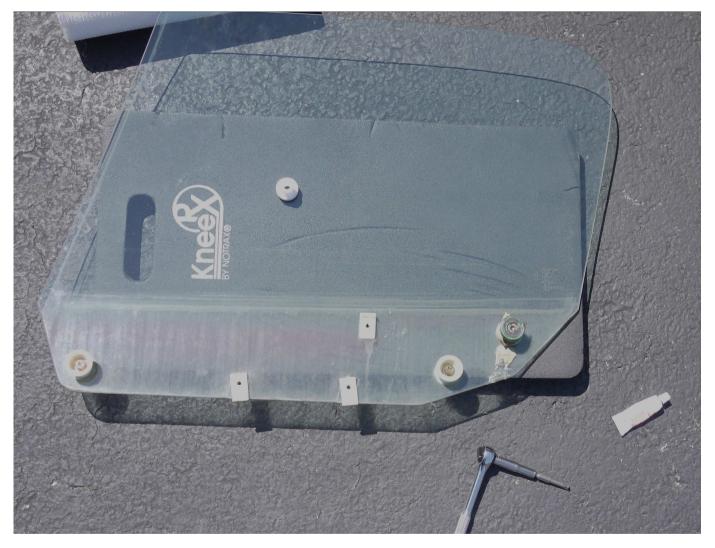
Carefully remove the glass and lay down, 'outside' down for guide replacement. :

In this picture, I have the glass lying on top of a knee pad. The white item in the middle of the glass is the new replacement piece. The bottom lower rear is the piece to be replaced held on by a single T30 screw. The plastic clips near the center bottom were the clips that held the glass in place. And the two larger pieces outboard of the clips what hits the top L-shaped feet removed earlier. Replacing the guide is a matter of removing the old and replacing with the new. When reinstalling any screws against the glass, be careful to not over torque the screws

When reinstalling any screws against the glass, be careful to not over torque the screws.

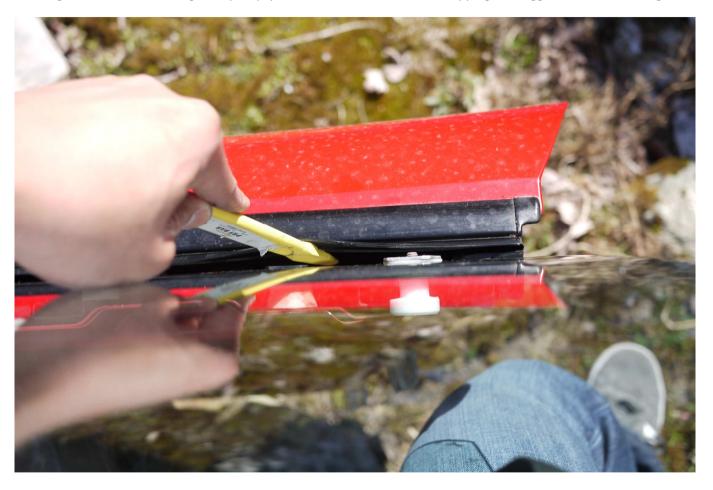
Also note, when reinserting the glass back into the door, I found it necessary to pry along the outside weather stripping to prevent the glass hardware from catching it. Like so, but running the nylon pry back all across the weather stripping as I wiggled it in to seat the glass.
