# How to remove, replace and tighten accessory belts for a second generation (NB, 1999-2005 ) Mazda Miata MX-5

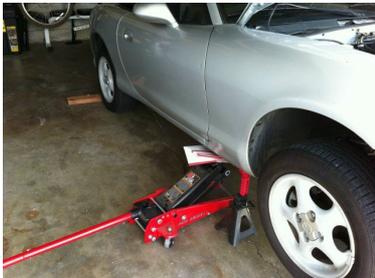
Setup your car. Jack the front wheels and put them on stands. Cardboard on the jack can help prevent dents in the metal. Make sure the parking break is on and that you block the rear wheels. Leaving the jack extended on one gives you added insurance.

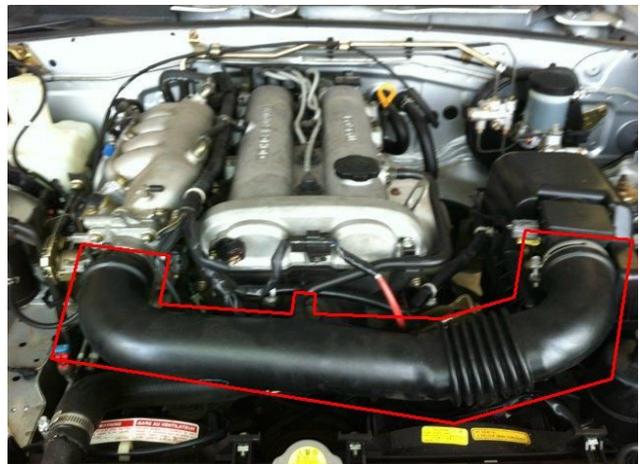
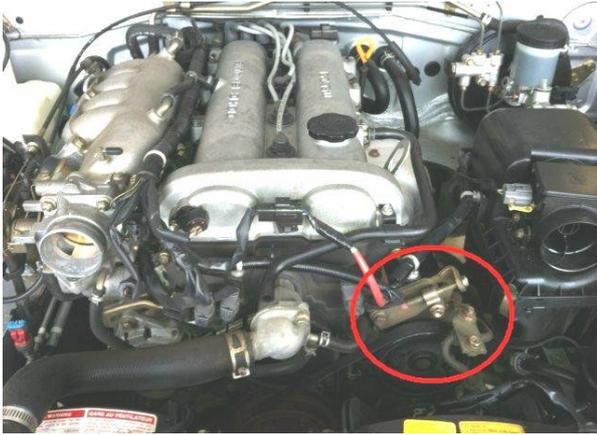
Open your hood. To get at the belts you must remove the air duct just behind your radiator. It is attached at three points. Use your screwdriver to loosen the clamps on either end, then remove the middle clip with pliers. Wiggle the duct off each connection.

The belt closest to the radiator goes from the engine to the air conditioner compressor then the power steering. Not all miatas have this belt depending on A/C on power steering. The tension in this belt comes from the air conditioner compressor pulley. The tensioner (circled) needs to be adjusted to remove the belt.

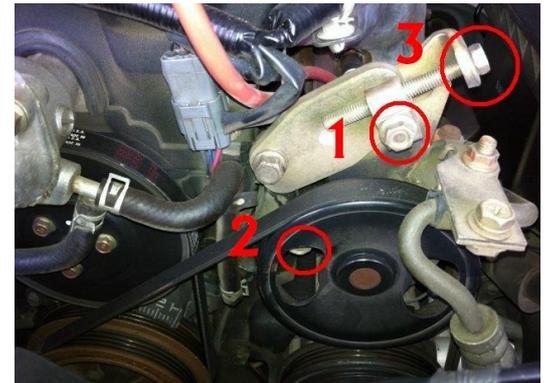
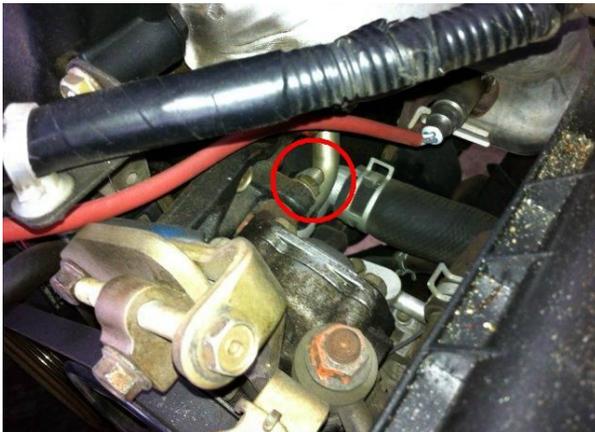
Three bolts are used to adjust this tensioner. Bolt 2 is accessible through a gap in the power steering pump pulley. It may be necessary to turn over the engine to line up the bolt with the gap. The car will not run with the air duct out, but it should turn over. Loosen the bolts in the numbered order. Bolts 1 & 3 are 12mm and bolt 2 is 14mm.

You may need to secure the nut on opposite end of bolt 2. Use a 14mm wrench on the nut circled (photo looking over the top of the tensioner into engine compartment).

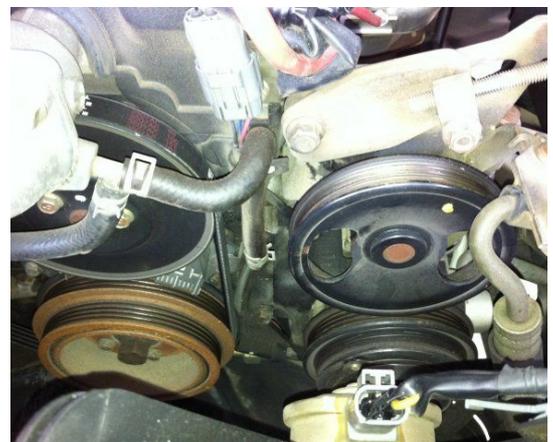
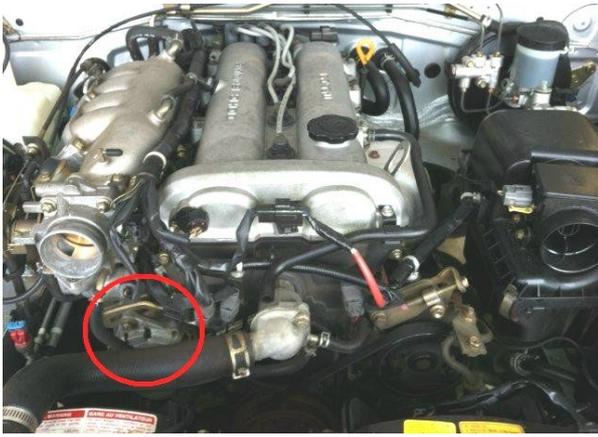
Loosen bolt 3 to slowly drop the air conditioning compressor down. A wrench is probably better so you don't get interference with the air intake using a ratchet. If you just want to tighten this belt, then skip down to page 5. Slip off the belt.

The second belt goes from the engine to the water pump pulley above then the alternator. The tension in this belt comes from the alternator compressor pulley. The tensioner (circled) needs to be adjusted to remove the belt.

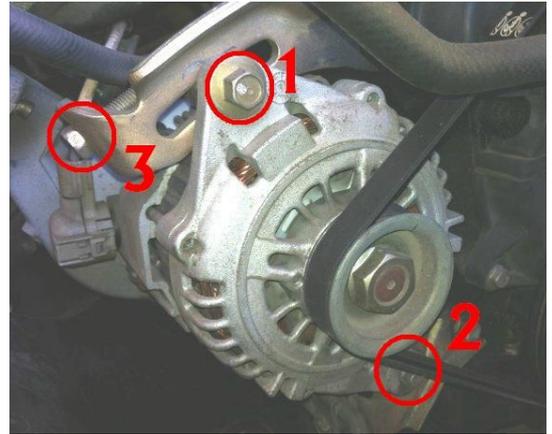
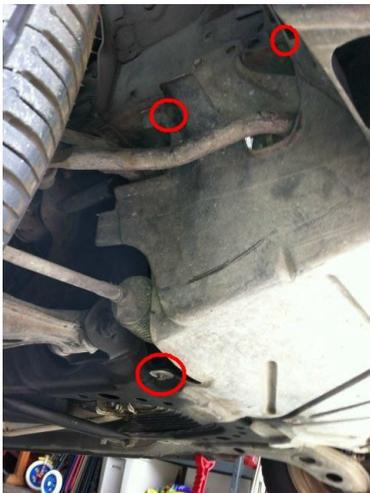
Again, three bolts are used to adjust this tensioner. Bolt 2 is access from under and behind the alternator. We need to remove the splash guard under the car for access. Loosen bolt 1 using a 12mm socket.

You can get away with just removing the fasteners on the passenger side of the splash guard to access bolt 2. There should be 10mm bolts and Philips head screws holding it up. The left photo shows about where the bolts are (taken from below the car in front of the passenger tire, looking up). On the right shows the location of bolt 2 after the splash guard is moved (behind the coolant line).

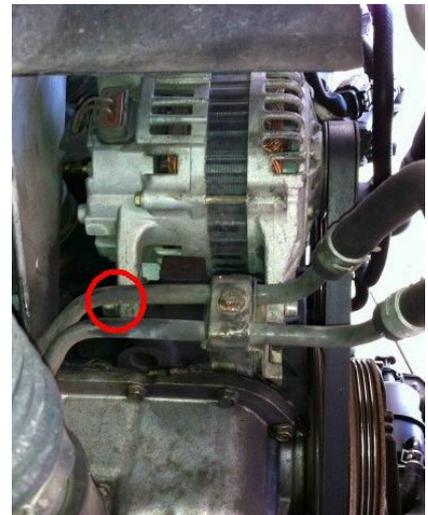
Use a 14mm wrench to loosen bolt 2. Get up and dust yourself off. Loosen bolt 3 with a 12mm socket to move the alternator. If you just want to tighten this belt, then skip down to the next page. Slip off the belt.

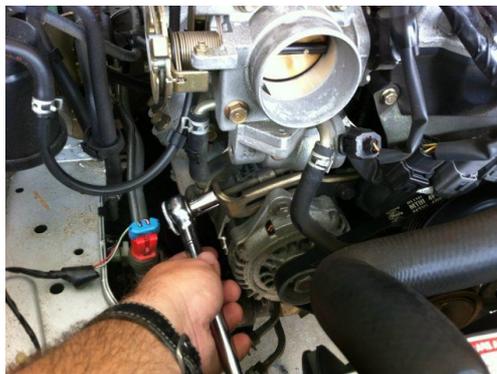
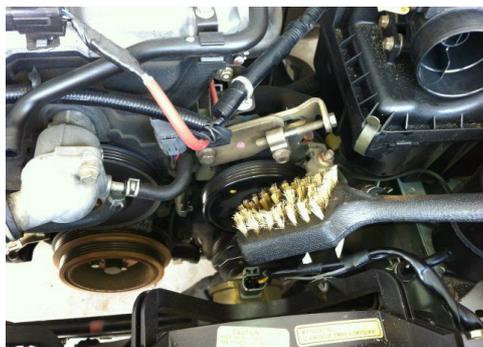
Use the brass brush to scrub off the pulleys, especially if there is lots of gunk. Some people have used brake pad cleaner if they are really nasty. Brass is important because a steel brush can possibly score the pulleys, which wear the belts faster.

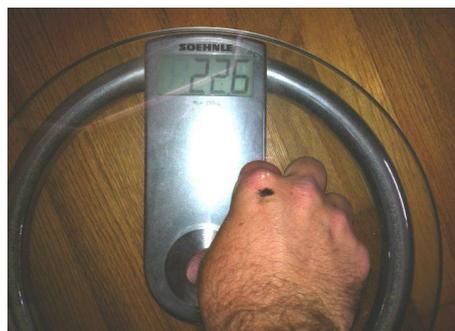
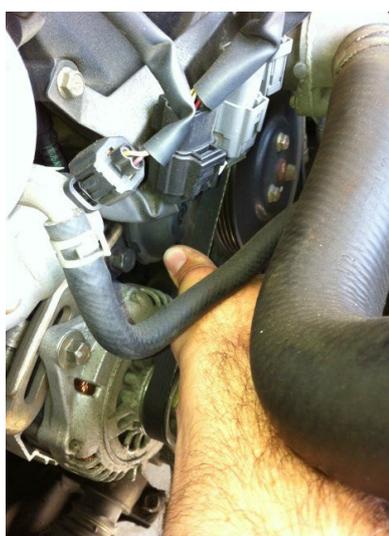
Put the new belt on the alternator loop. First wrap it around the water pump pulley, then the engine pulley (the groove closest to the engine) and lastly around the alternator. As you tighten bolt 3, check the tension on the belt with your *calibrated* finger. The belt need to be tightened so that 22 lbs causes 1/3 inch deflection. If you don't trust your finger, then you can get a belt tension gauge like the one to the right.

Tighten bolt 2 and then bolt 1. Reattach the splash guard under the car. Move onto the next belt.

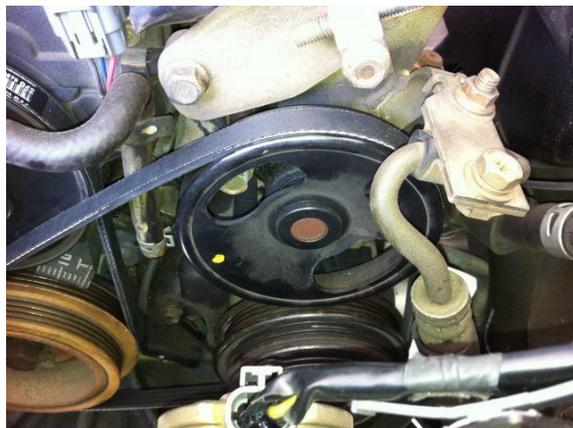
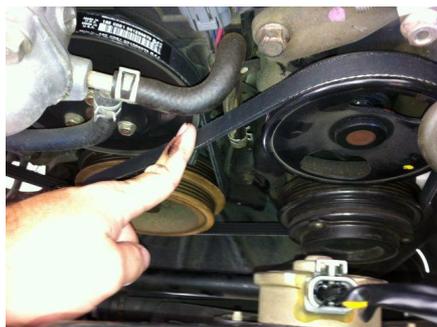
Stretch the new air conditioning belt around the engine pulley (the groove closes to the radiator), then the power steering pump pulley and finally around the air conditioning compressor pulley. While the belt is loose, orient the power steering pulley so that bolt 2 is accessible through the gap.

Tighten bolt 3 while checking the tension on the belt with your finger. The belt should be tightened so that 22 lbs causes 1/3 inch deflection. Tighten bolt 2 then bolt 1.

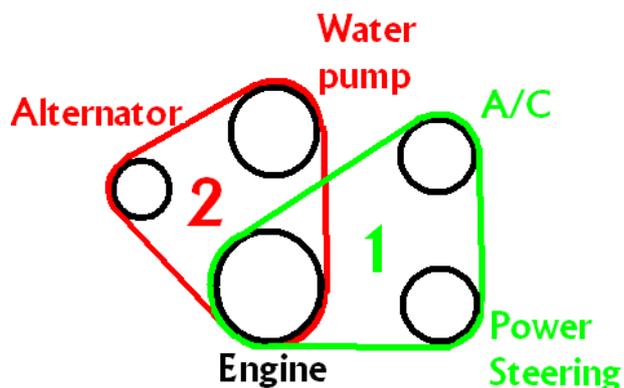
This crude diagram show you the routing of the belts. Belt 1 is in front of belt 2.
