Service Information

Category S	Technical	Ref. No. E013/15	Page 1 of 3
Coverage <input type="checkbox"/> Distributor only <input checked="" type="checkbox"/> Please inform your dealers		Date Issued August 27, 2015	
Please convey this information to your <input type="checkbox"/> Director <input checked="" type="checkbox"/> General Manager <input checked="" type="checkbox"/> Warranty Dept. <input checked="" type="checkbox"/> Parts Dept. <input checked="" type="checkbox"/> Training Dept. <input checked="" type="checkbox"/> Field Rep.		Date Revised	
Applicable Model MX-5 (ND)		Applicable Countries or Specifications Worldwide

Subject: Possible Paint Damage to Trunk Lid Opening when removing Rear Combination Light [Service Note]

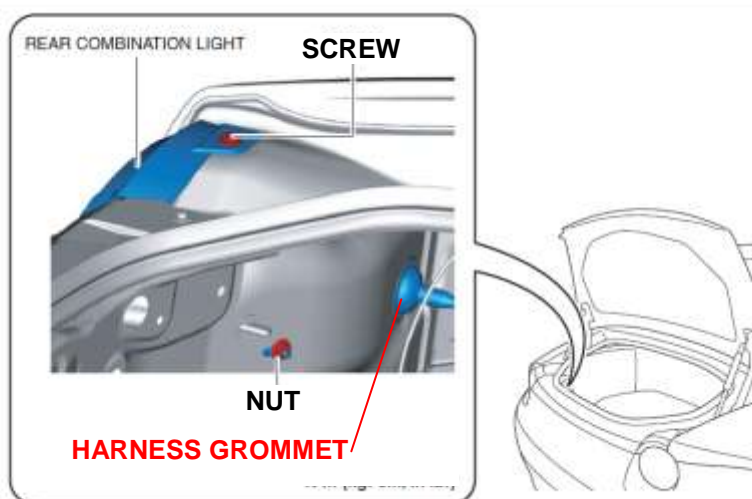
1. Disconnect the negative battery cable. (See NEGATIVE BATTERY CABLE DISCONNECTION/CONNECTION.)
2. Remove the trunk end trim. (See TRUNK END TRIM REMOVAL/INSTALLATION.)
3. Partially peel back the trunk side trim. (See TRUNK SIDE TRIM REMOVAL/INSTALLATION.)
4. Remove the screw.

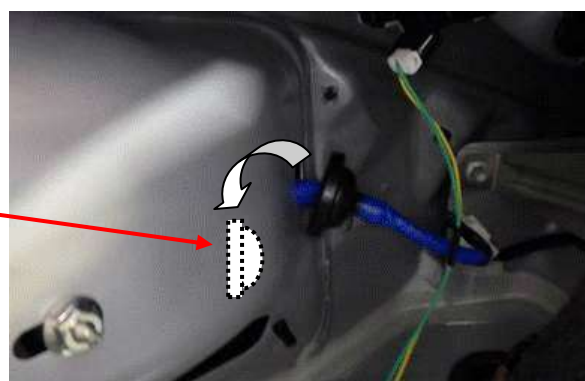
Harness Grommet
Remove and drop it in the
combination light.

5. Remove the nut.
6. Remove the harness grommet and drop it in the rear combination light.
