# 99-05 Mazda Miata Tension Cable Replacement

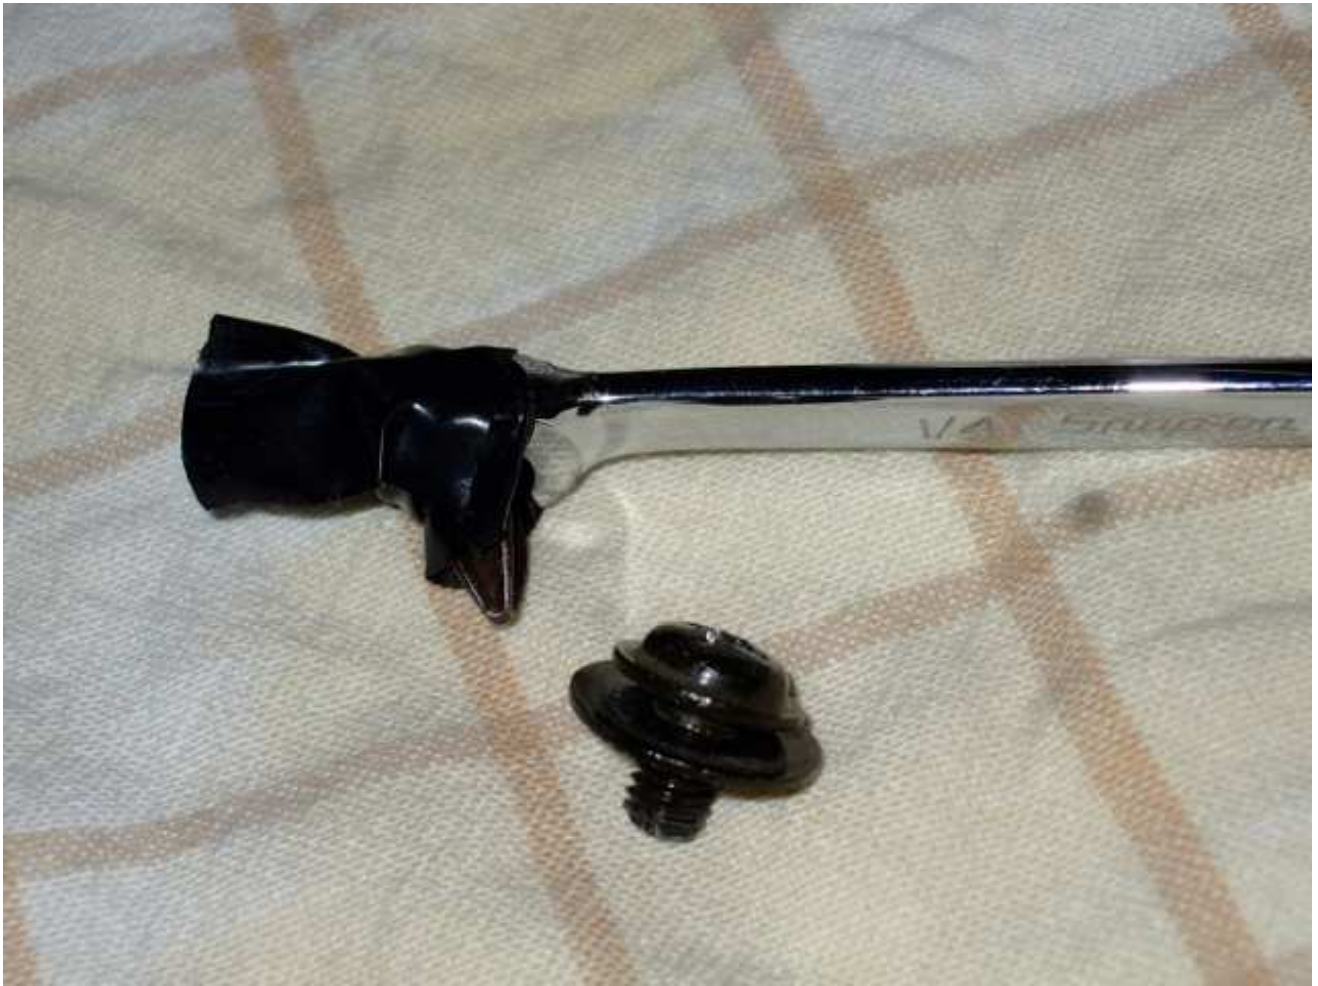
This one you have to make (or you can borrow mine, if you're in the area, I guess). Many of you probably have one or a dozen in the garage: a 1/4" drive PH3 Philips head bit. Insert that bit into the 1/4" flare nut wrench such that just enough of the Philips head sticks out of the wrench and mark the hex end that protrudes out the other end. This material of that bit needs to be removed. I accomplished this using a bench vice and an angle grinder. This is unnecessary if you happen to have an L shaped offset with very low clearance. Nearly all my offsets are "Z" shaped. Reinsert the bit into the flare nut wrench and use electrical tape to hold it in place. Using a flare nut wrench prevents accidentally and repetitive dropping of the bit.

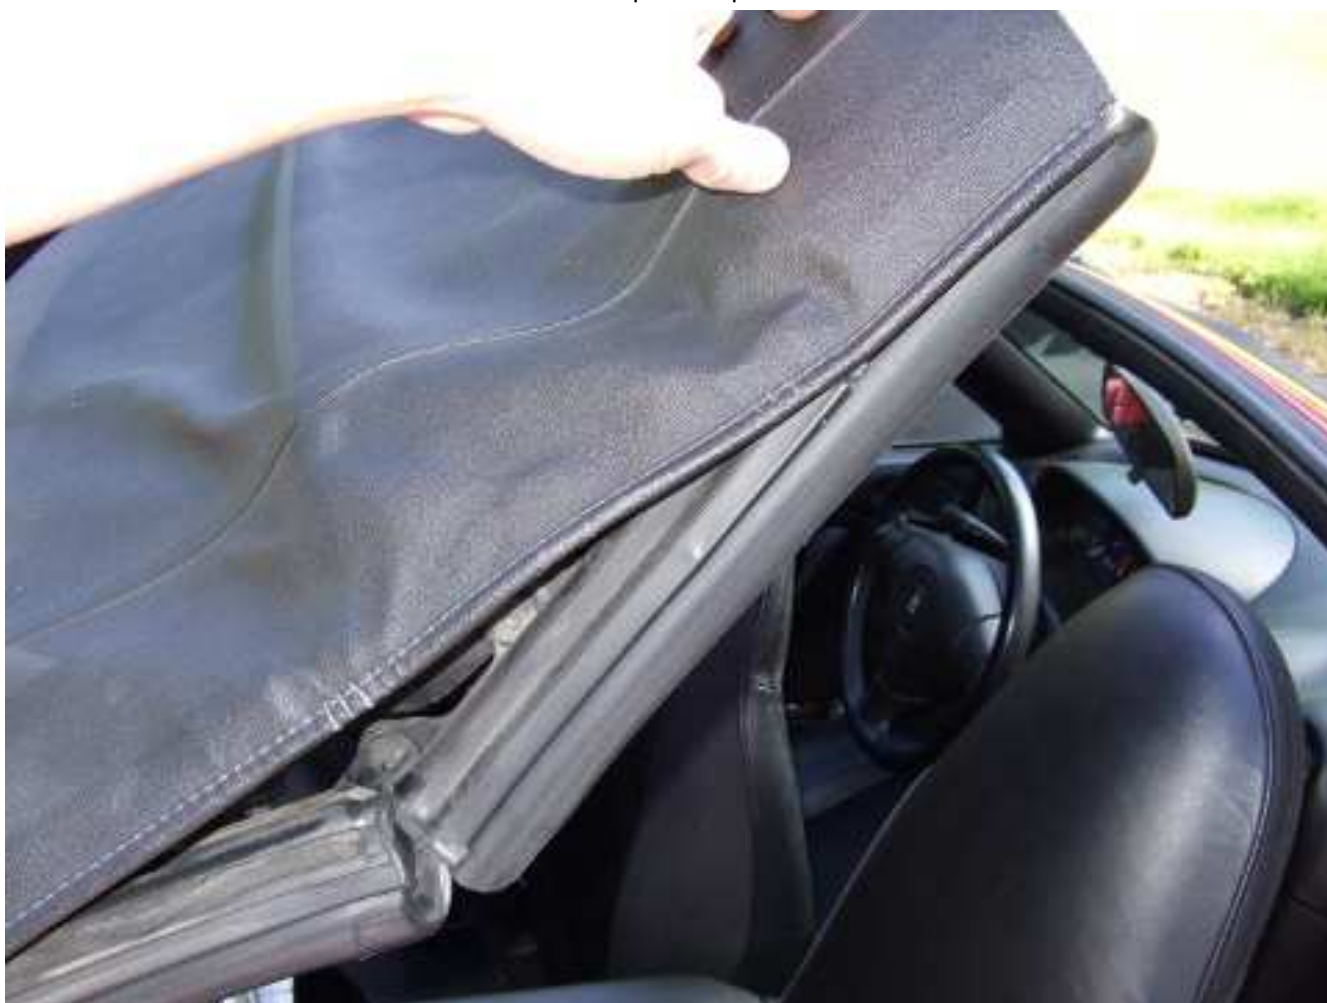
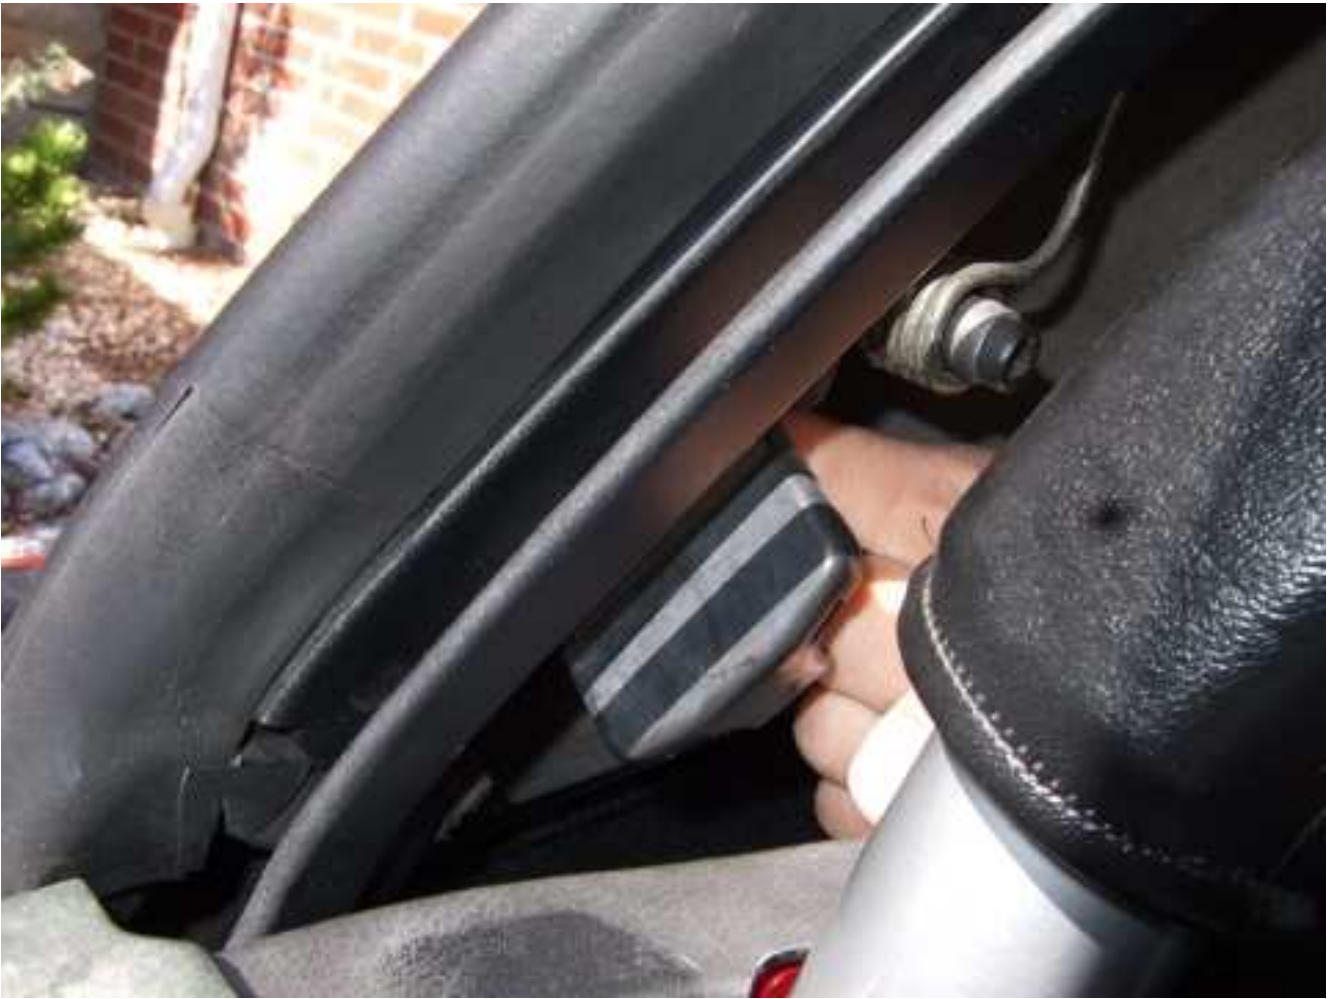
The blind Philips head bolt is located behind this piece of plastic and faces “outboard”. It’s the only Philips head in that general area. Again, this procedure is for the passenger side. Following up, you should feel the tension spring. This would’ve been a little bit easier if the roll bar wasn’t in the way.
