# Service Information

Category <b>T</b>	<b>Technical</b>	Ref. No. <b>E006/09A</b>	Page 1 of 4
Coverage <input type="checkbox"/> Distributor only <input checked="" type="checkbox"/> Please inform your dealers		Date Issued <b>January 27, 2009</b>	
Please convey this information to your <input type="checkbox"/> Director <input checked="" type="checkbox"/> General Manager <input checked="" type="checkbox"/> Warranty Dept. <input checked="" type="checkbox"/> Parts Dept. <input checked="" type="checkbox"/> Training Dept. <input checked="" type="checkbox"/> Field Rep.		Date Revised <b>January 8, 2014</b>	
Applicable Model  <b>All Models</b>		Applicable Countries or Specifications  Worldwide

## Subject: Foggy Lens (Condensation) of Headlight, Rear Combination Light and Other Lamps

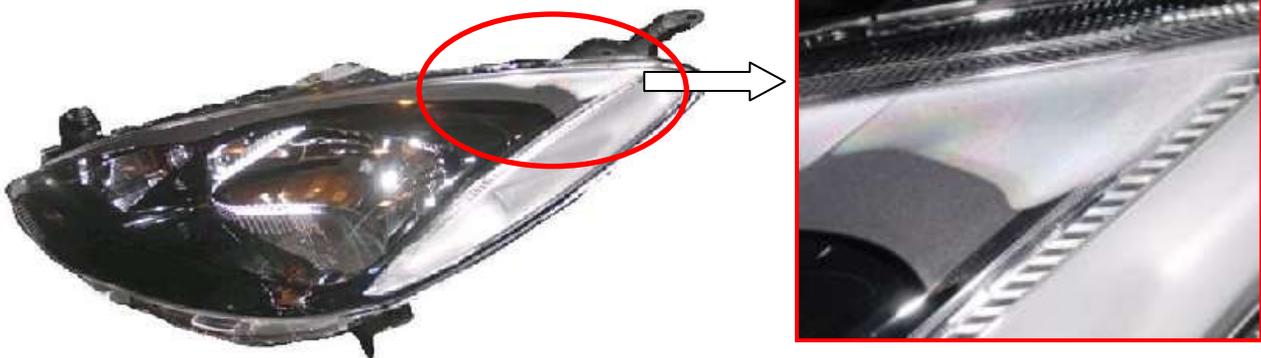
The fog will be cleared off as the temperature rises with the lights on or as the time passes.

Temporary Measure: Remove the bulb and socket, and send air using a drier through the hole.

Note 1: Do NOT use warm / hot air because there is a possibility that the lamp may get melted.

Note 2: Perform this work in a dry place. (Outside in good weather would be the best.)

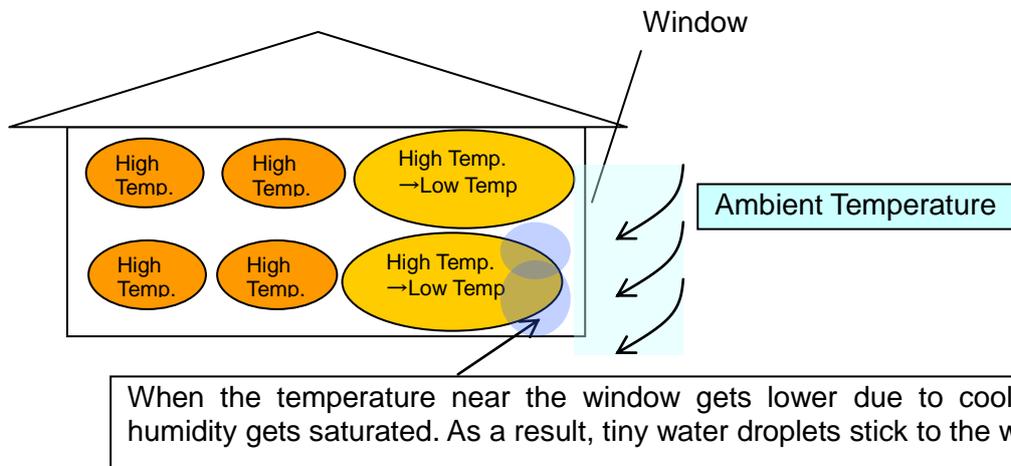
<Example: Condensation on Window Glass inside Room>

The mechanism of condensation on the lamps is the same as on the window glass in the house.

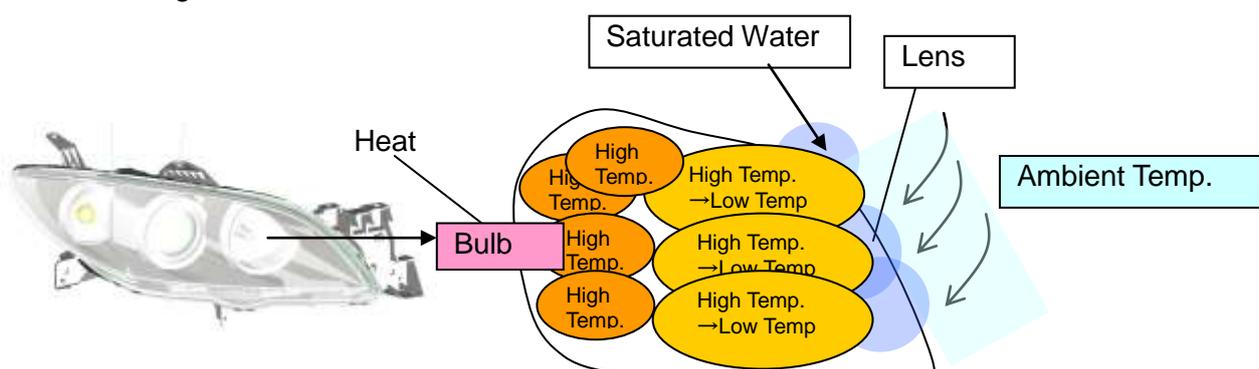
- (1) Due to heat emitted from the lamp bulb or sunlight, the temperature inside the lamp unit gets higher. Or, warm and humid air **gets** into the lamp unit from the engine compartment. This will allow the air inside the lamp unit to include lots of moisture.
- (2) When the lamps are turned off or the outside temperature gets too low, the temperature of the lamp **unit** surface also gets low. Car wash also allows the light lens **temperature** to get low. These events will cause a saturated condition.
- (3) Saturated water **results in** tiny droplets and sticks to the light lens. When the above-mentioned conditions 1 and 2 are caused frequently, high humid air stays inside the lamp unit. As a result, condensation occurs.  
Note: **First** the condensation appears around the edge of the **lamp** unit in which the air is stagnant.
