Service Information

Category T	Repair Guidance		Ref. No. R088/17	Page 1 of 15
Coverage ☐ Distributor only ■ Please inform your dealers			Date Issued December 28, 2017	
Please convey this information to your ☐ Director ☐ General Manager ☐ Warranty Dept. ☐ Parts Dept. ☐ Training Dept. ☐ Field Rep.		· ·	Date Revised	
Applicable Model Applicable Countries and/or Vehicle Specifications		3		
MX-5 (ND)		Worldwide

Subject: Engine will not start (Engine can start if touching Push Button Start using Backside of Key)

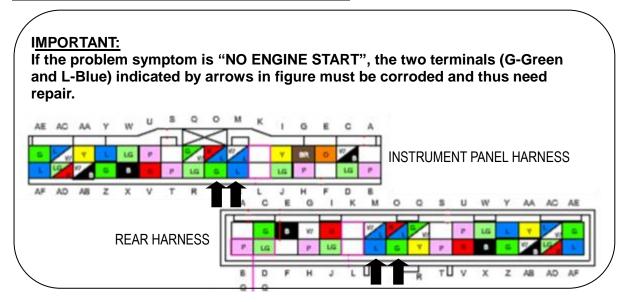
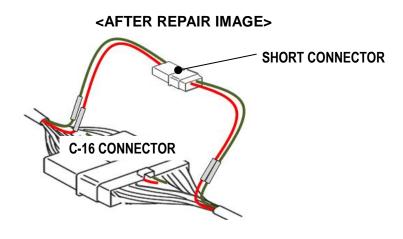
3. Inspect terminals of the C-16 connector for any corrosion.

If any terminal(s) is corroded, cut all the affected wires and connect them using a short connector from the repair kit. Go to step 4.
