Subject: MAZDA CONNECT FUNCTIONALITY CONCERNS	Bulletin No: 09-022/15
	Last Issued: 08/10/2015

MAZDA CONNECT Software Version Verification Procedure

Reflash Procedure

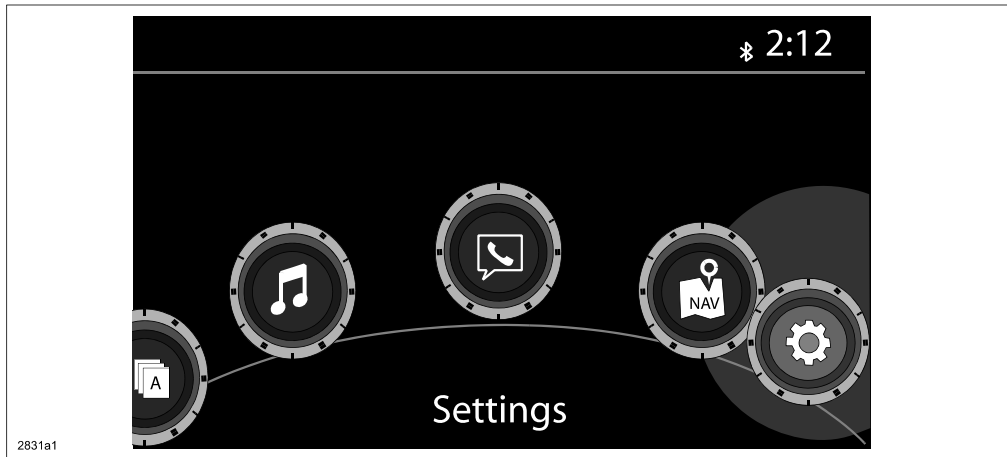
1. Select "Settings" from the Home screen to check the software version.

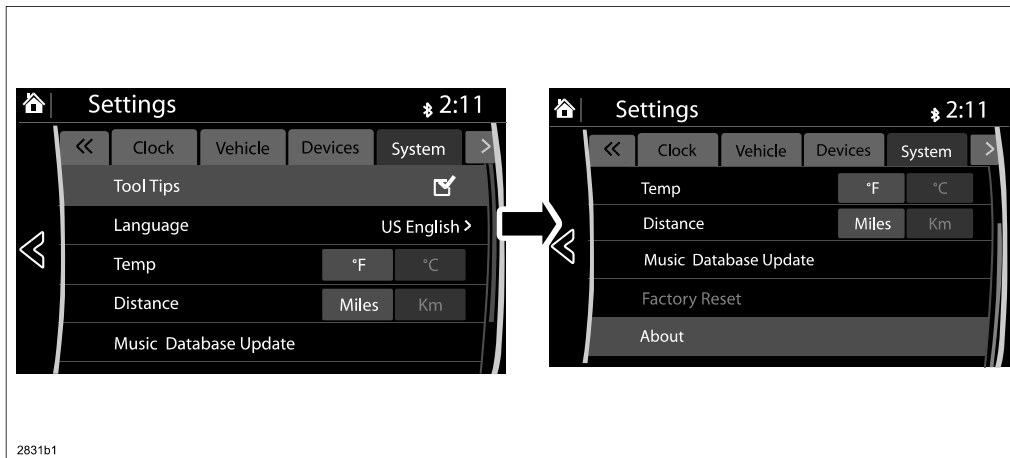
2. Select "System" and scroll down to the "About" option.

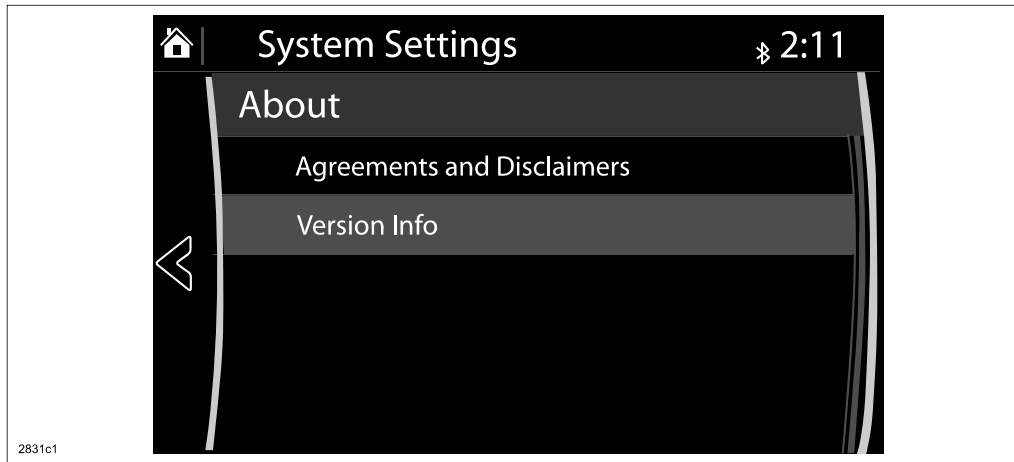
3. Select "Version Info" from the "About" screen.

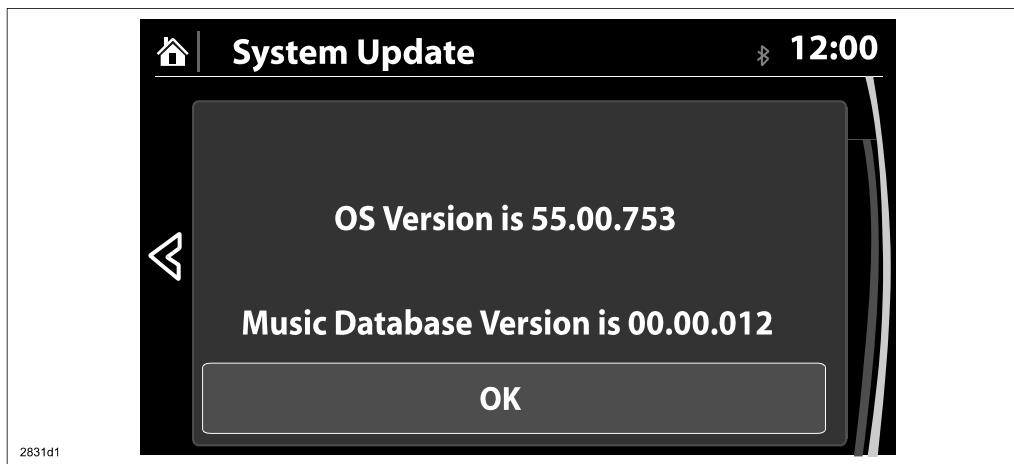
4. Make sure the software version is **55.00.753** or later, then select OK. If it is not **55.00.753** or later, update the system using a USB memory stick with the latest software according to the "Reflash Procedure." If needed, refer to "Downloading Update Software to a USB Memory Stick (for additional USB memory sticks)" below.

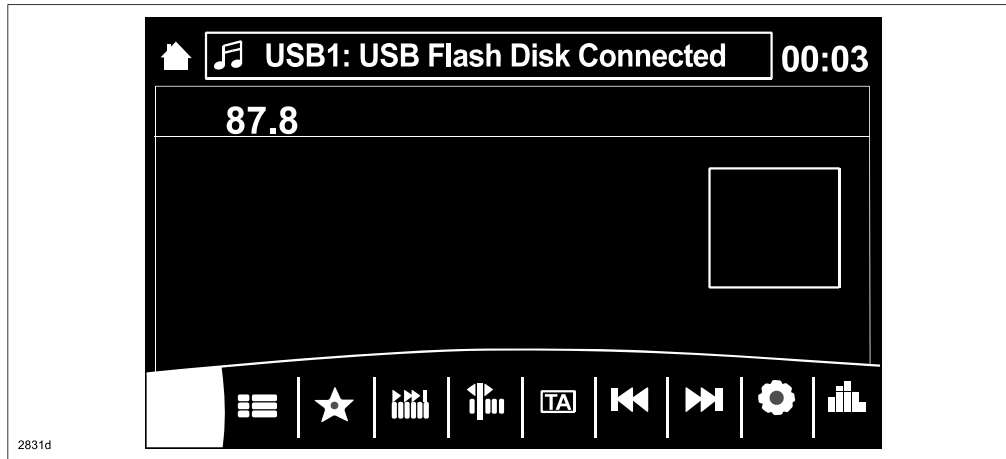
9. When the USB memory stick is recognized, the following message will appear briefly on the screen.

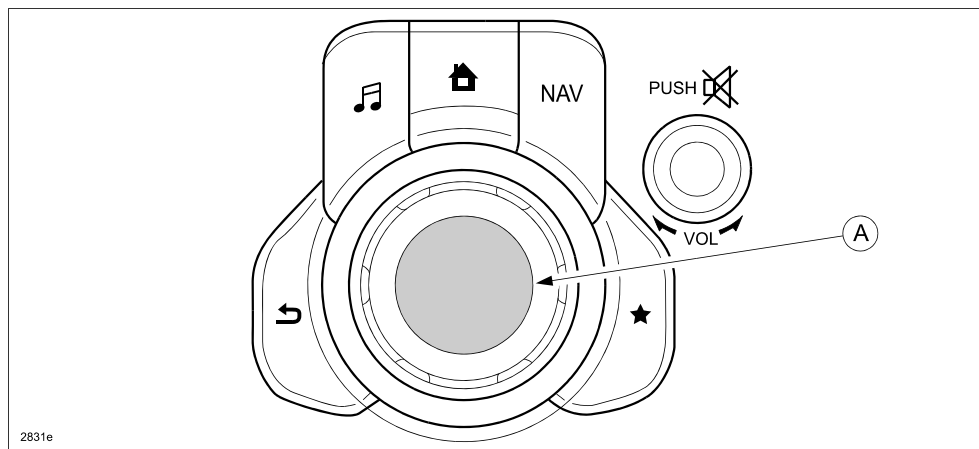
- It takes approx. 5 seconds before the USB memory stick is recognized.
- If the USB memory stick is not recognized, perform the following:
 - (1) Select "Setting".
 - (2) Select "System".
 - (3) Select "Factory Reset".
 - (4) Push the commander switch knob (A) to "Enter".

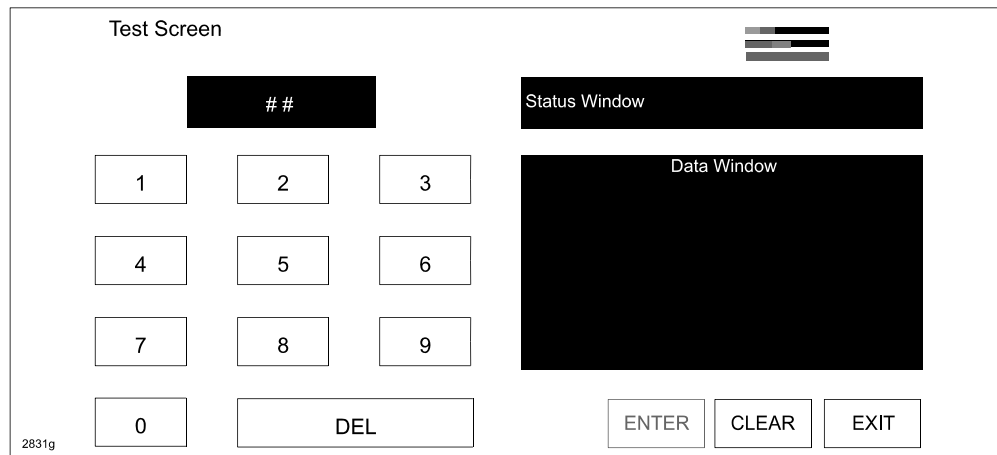
10. Press the three buttons (Music (A) + Favorites (B) + Volume Mute(C)) on the commander switch at the same time for 2-5 seconds and the Diagnostic Test Screen will appear.

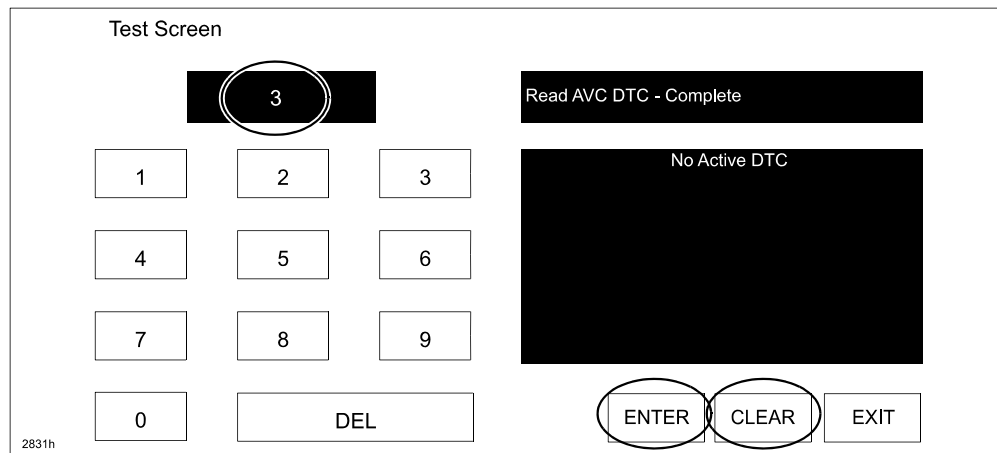
11. On the test screen, input '3' and then select "ENTER" to verify whether any DTCs (in the CMU) are active. Select "CLEAR" to go next step.

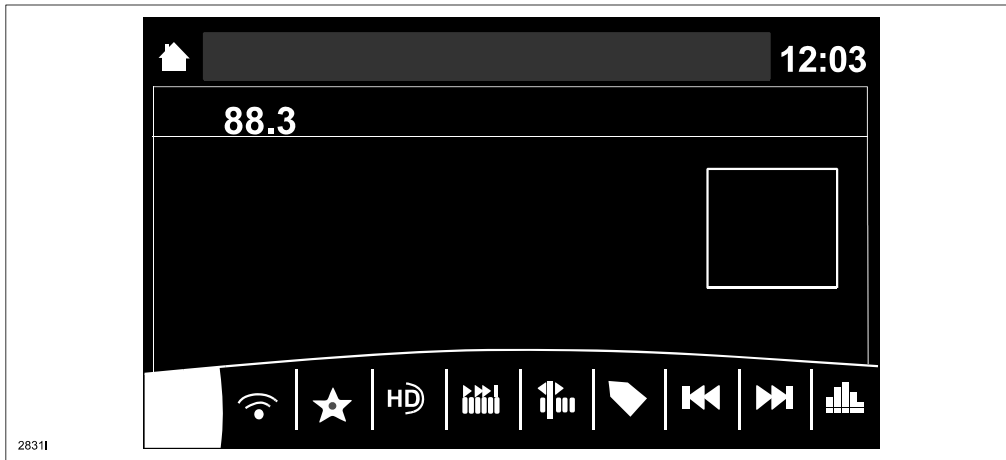
NOTE: If the following screen is displayed, perform the following.

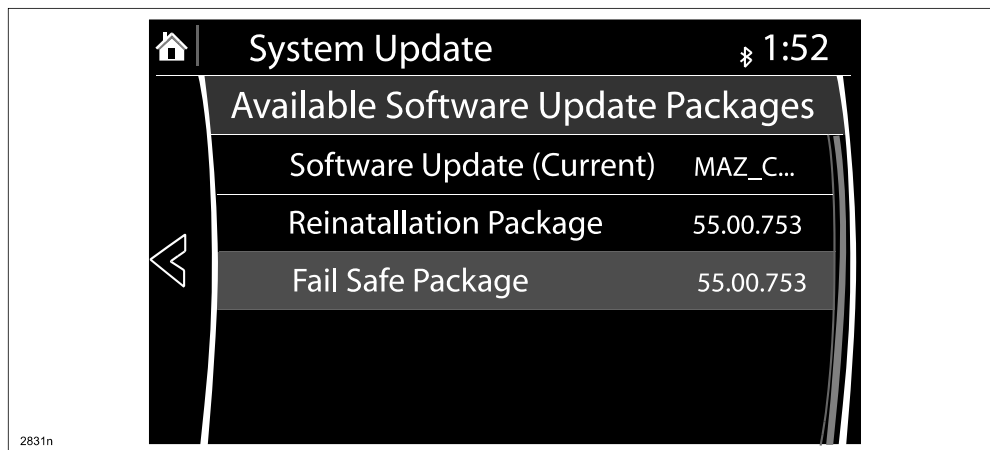
(2) Verify that the screen changes back to the screen below.

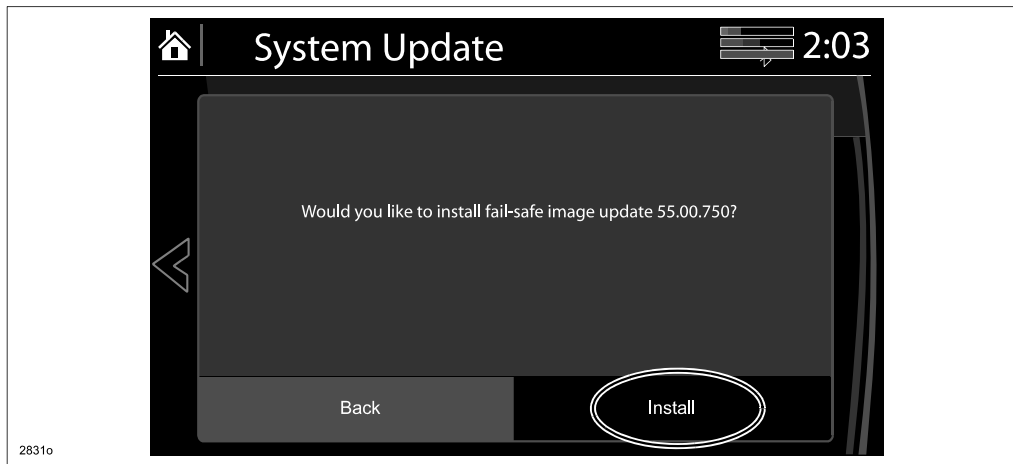
15. Select “Fail Safe Package” first using the touch screen.

CAUTION: Always do the “Fail Safe Package” first, followed by “Reinstallation Package”.

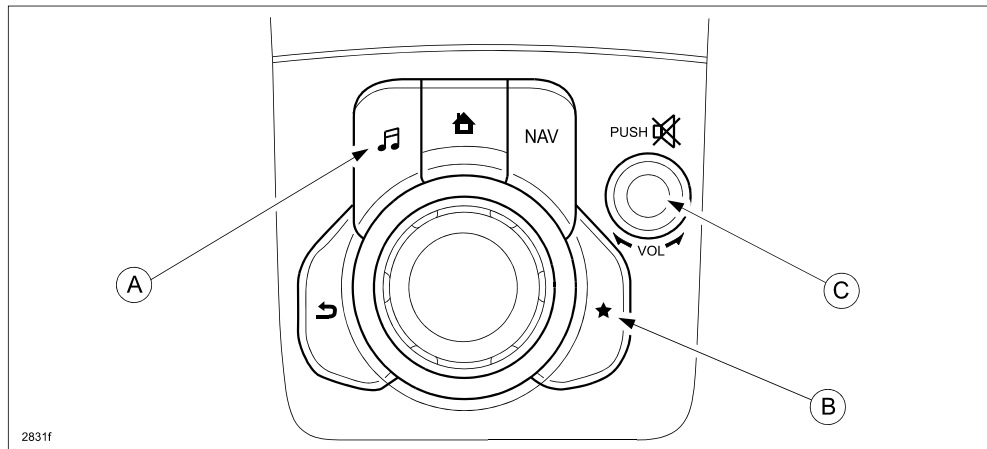
19. Press the three buttons (Music (A) + Favorites (B) + Volume Mute(C)) on the commander switch at the same time for 2-5 seconds to open the Diagnostics Test screen again.

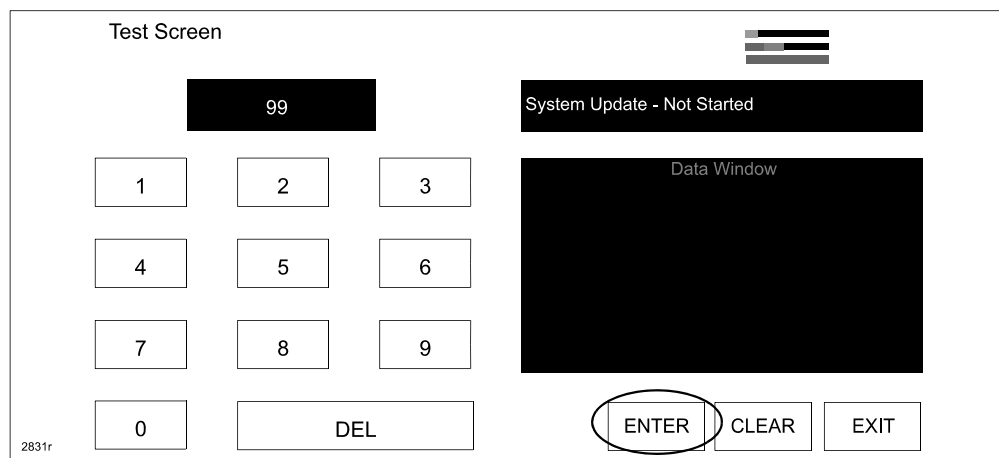
20. Use the touchscreen or the commander switch to input '99' and then select "ENTER" on the Test screen.

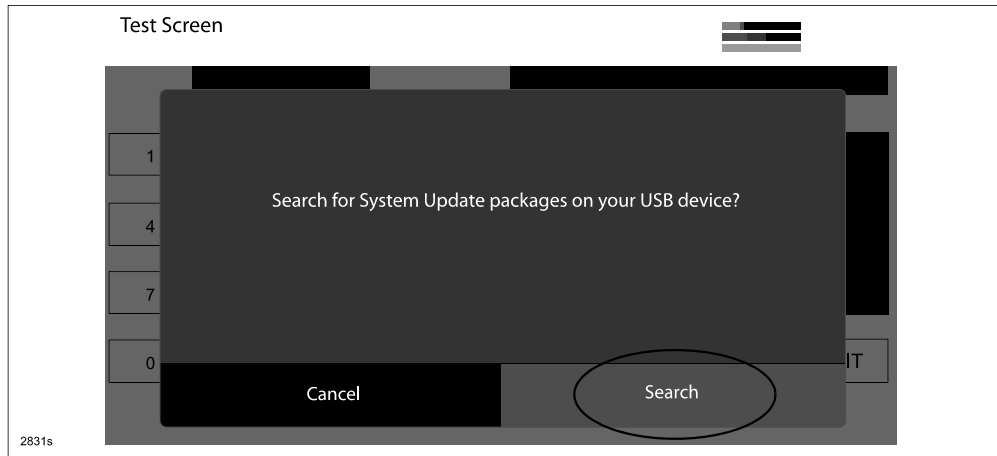
21. Select "Search" on the screen below.

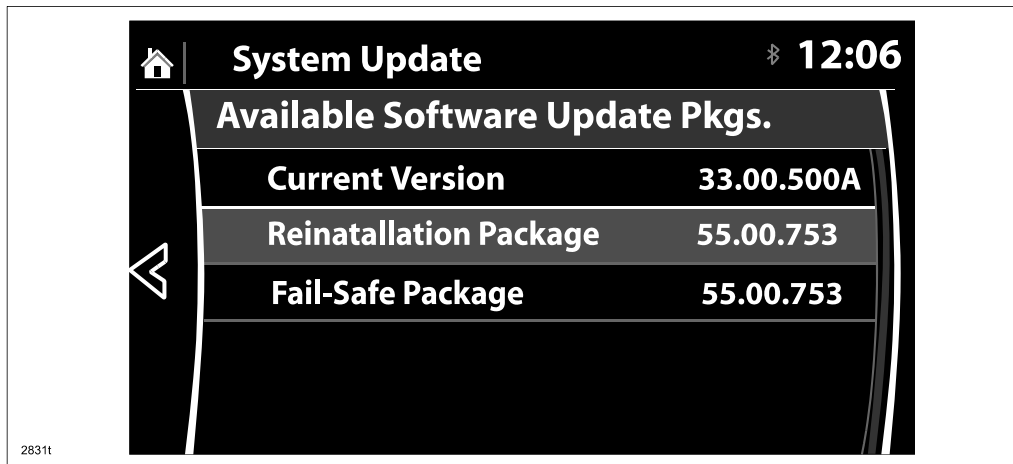
22. Select "Reinstallation Package" on the screen below.

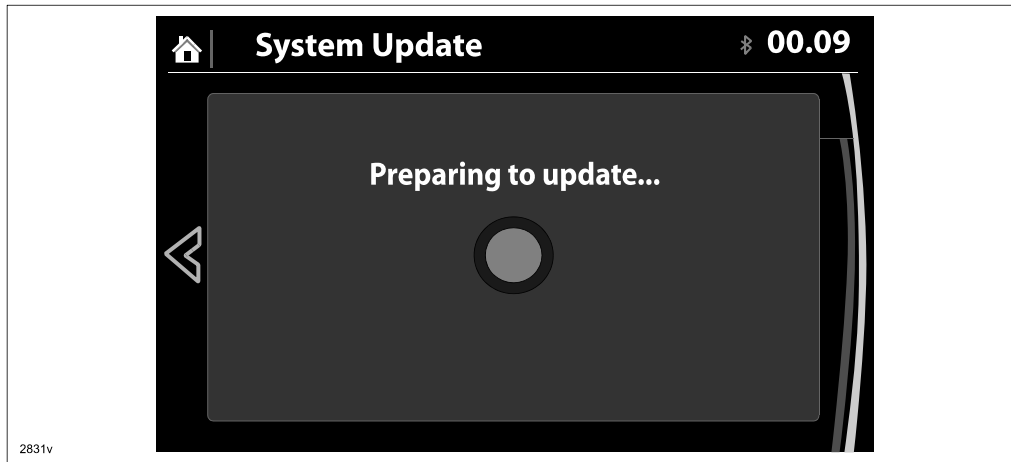
24. The screen below will be displayed.

NOTE: A blank screen is displayed momentarily. It will take approx. 2 minutes before the reflashing process moves to the next screen.

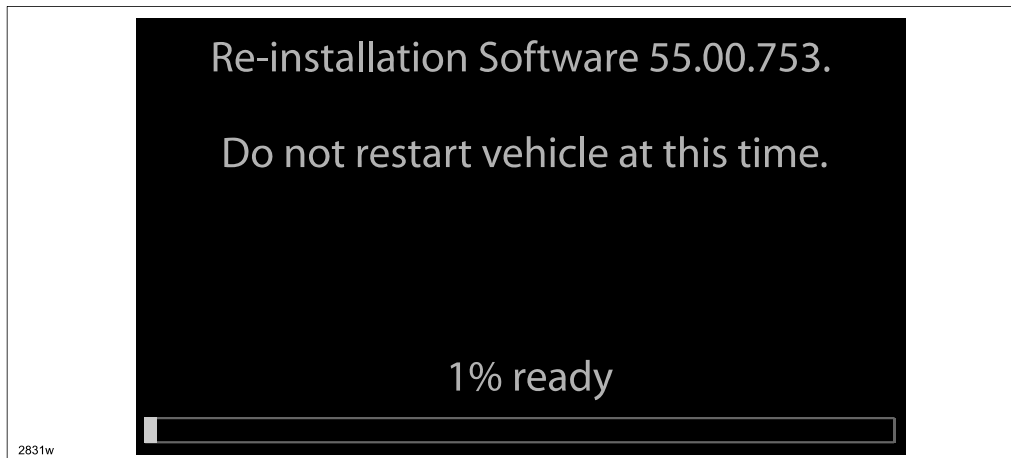
25. Reinstallation will start from 0% and as the reflashing process takes place, the progress bar will gradually increase to 100%.

NOTE: It may be difficult to read the display at times as it becomes dark, but "Do not restart vehicle at this time" is displayed.

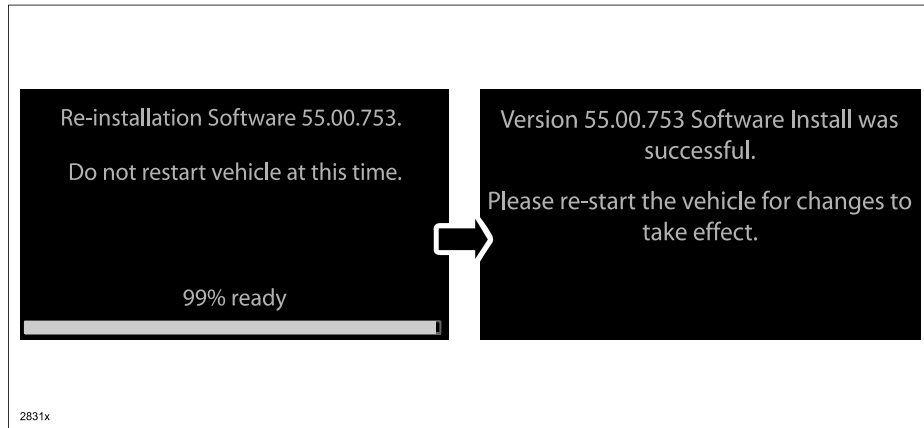
NOTE: It will take some time for the reflashing process to get from 98 % to “100%.”

26. After the update is completed with the above right screen, confirm that the push button start indicator light is illuminated (amber) and the display in the instrument cluster is OFF (ignition is in “ACC”). If the ignition is “OFF” and the push button start indicator light is not illuminated (amber), turn the ignition to “ACC” and one of the following two screens will be displayed.

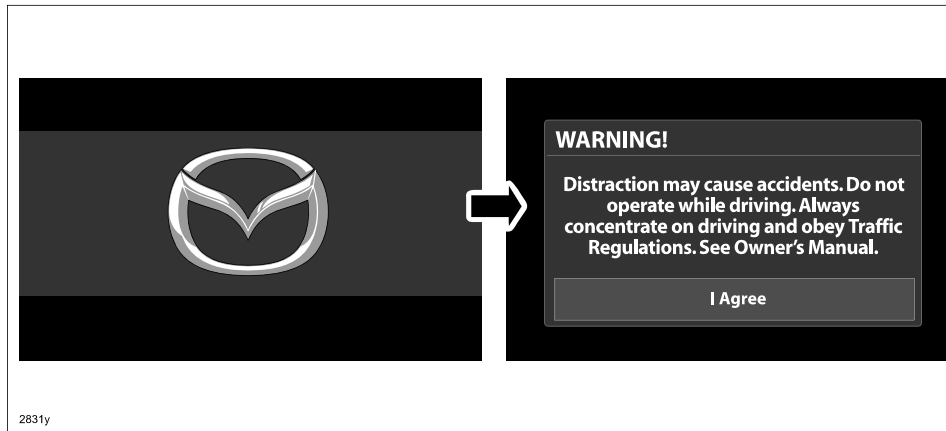
Type A: Reprogramming has already been completed. Go to next step.

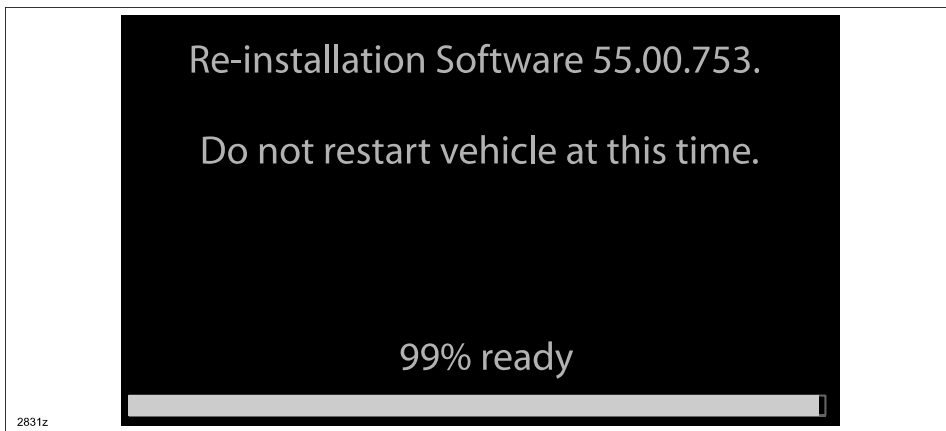
Type B: The ignition was turned “OFF” during the reflashing process. This screen will continue to be displayed until reflashing is completed. After the reflashing is completed, go to next step.
