Technical Service Bulletin

Subject: MAZDA SERVICE PROGRAM (MSP53) PANIC ALARM SYSTEM ACTIVATES WHILE DRIVING	Bulletin No.: 09-013/19
	Last Issued: 03/14/2019

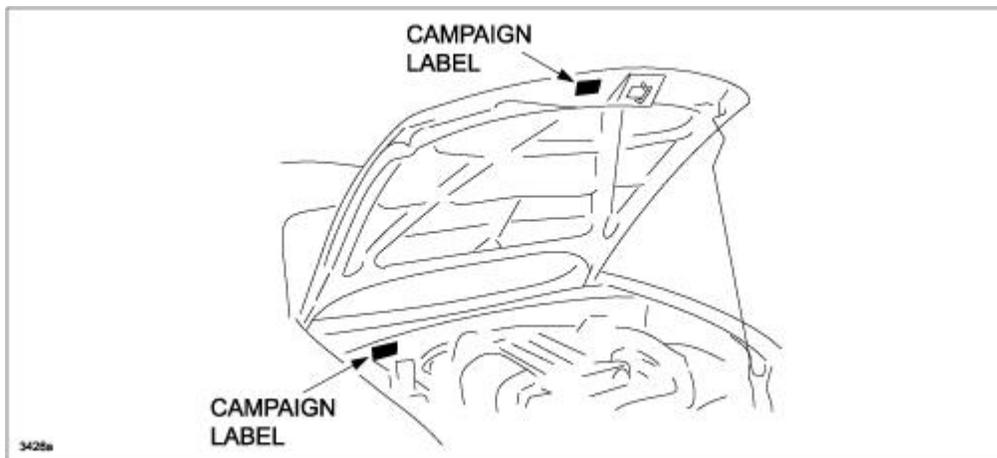
NOTE: Verify the campaign number as the vehicle may have multiple labels.

Refer to eMDCS System - Warranty Vehicle Inquiry Results table below.
