# Service Bulletin

Subject:	Bulletin No:	01-023/10
P0442 / P0455 / P0456	Last Issued:	10/15/2010

Some vehicles may have a MIL illumination with DTC's P0441, P0442, P0455, or P0456 stored in memory. To determine the location of the evaporative system leak, follow the repair procedure below.

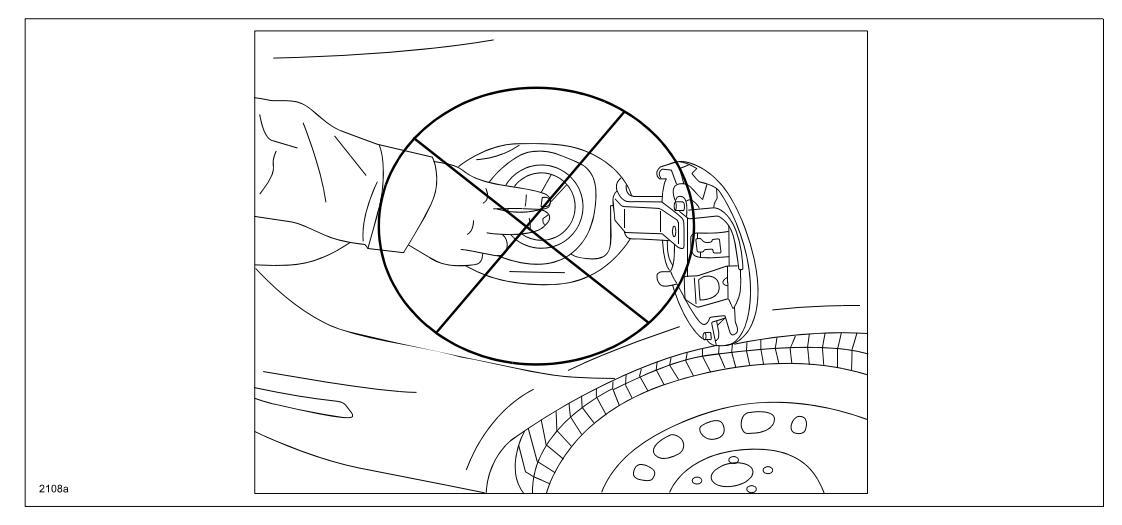
- P0441 is a DTC for purge flow, however, it can be stored when evaporative emissions are leaking from the fuel filler cap.
- Evaporative emissions leak from the fuel filler cap when the cap is not closed properly after refueling.
- When diagnosing an evaporative emissions leak from the fuel filler cap, DO NOT TOUCH the fuel filler cap.

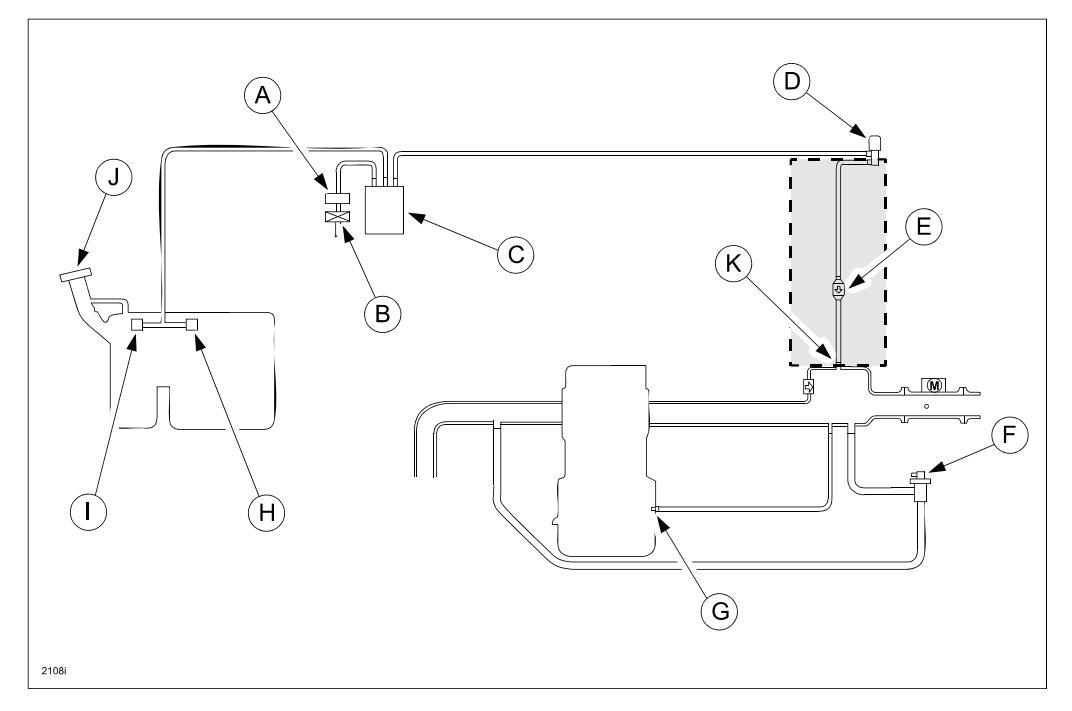
### System Structure:

A - EVAP System Leak Detection Pump	G - PCV Valve
B - Air Filter	H - Rollover Valve
C - Charcoal Canister	I - Fuel Shut-Off Valve
D - Purge Solenoid Valve	J - Fuel Filler Cap
E - Check Valve - (DISI Engine only)	K - Insert Generic Adapter (Purge Side)
F - EGR Valve

2. Check if both vacuum (a and b below) can be held between locations (K and D).	01- VAL	01-16 PURGE SOLENOID VALVE REMOVAL/INSTAL-
	a. Apply 60 kPa {18 inHg} of vacuum and verify it is within 60 kPa – 30 kPa {18 inHg - 9 inHg} when checked ten (10) seconds later.		LATION), then go to the next step.

b. Apply 10 kPa {3 inHg} of vacuum and verify it is within 10 kPa – 5 kPa {3 inHg - 2 inHg} when checked ten (10) seconds later.

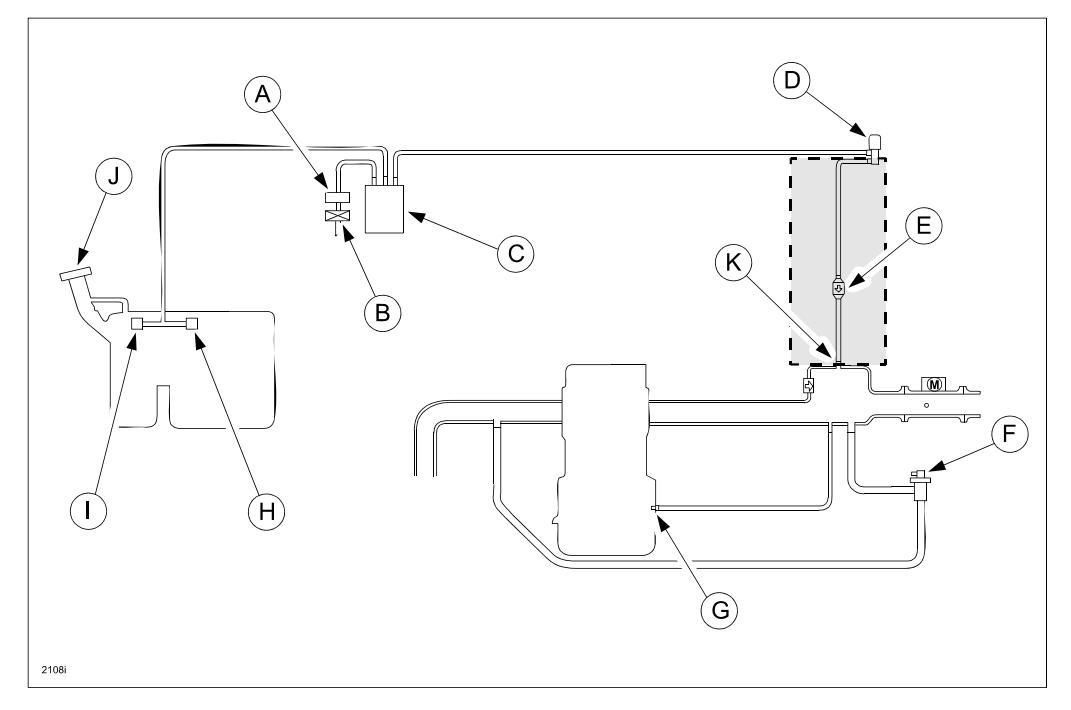
### System Structure:

A - EVAP System Leak Detection Pump	G - PCV Valve
B - Air Filter	H - Rollover Valve
C - Charcoal Canister	I - Fuel Shut-Off Valve
D - Purge Solenoid Valve	J - Fuel Filler Cap
E - Check Valve - (DISI Engine only)	K - Insert Generic Adapter (Purge Side)
F - EGR Valve

12	Check gas-tightening of purge valve referring to the "System Structure" below.	Yes	Both conditions (a and b) are met.
	1. Disconnect purge control valve vacuum tube, then		Go to the next step.
	adapter at location (K) (intake manifold side).	No	Neither conditions (a or b)
	NOTE: DO NOT disconnect to the charcoal canister side (C).		Replace purge solenoid

2. Check if both vacuum (a and b below) can be held between locations (K and D).		valve (D) with a new part ac- cording to the appropriate
	a. Apply 60 kPa {18 inHg} of vacuum and verify it is within 60 kPa – 30 kPa {18 inHg - 9 inHg} when checked ten (10) seconds later.		Workshop Manual (section 01-16 PURGE SOLENOID VALVE REMOVAL/INSTAL-

b. Apply 10 kPa {3 inHg} of vacuum and verify it is within 10 kPa – 5 kPa {3 inHg - 2 inHg} when checked ten (10) seconds later.		LATION).

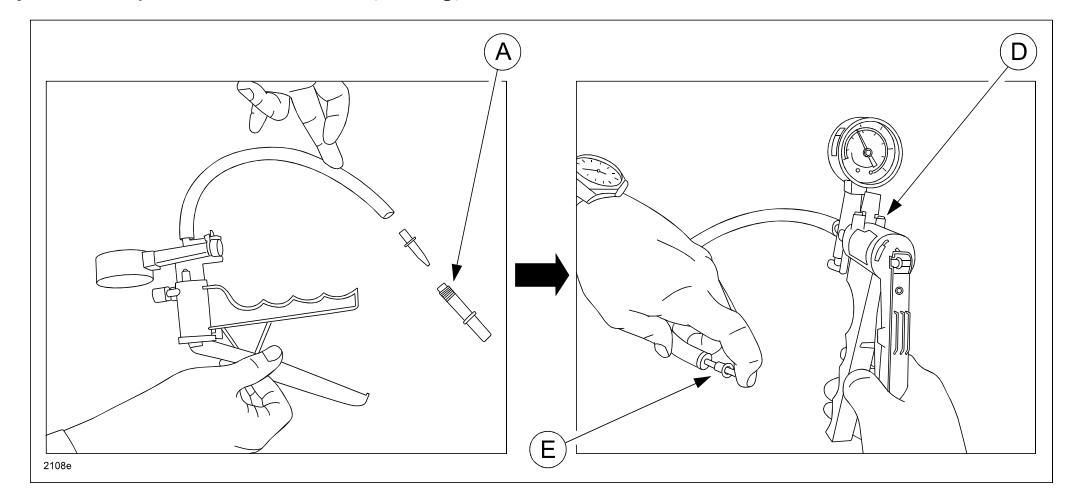
### Vacuum Pump Leak Test:

- 1. Perform leak test between vacuum pump and appropriate generic adapter (A) to be used during the testing:
  - a. Connect appropriate generic adapter to vacuum pump and ensure vacuum pressures (b and c) can be held between locations (D and E).
  - b. Apply vacuum pressure of 60 kPa {18 inHg} of vacuum and monitor for 20 seconds.
  - c. Apply vacuum pressure of 10 kPa {3 inHg} of vacuum and monitor for 20 seconds.

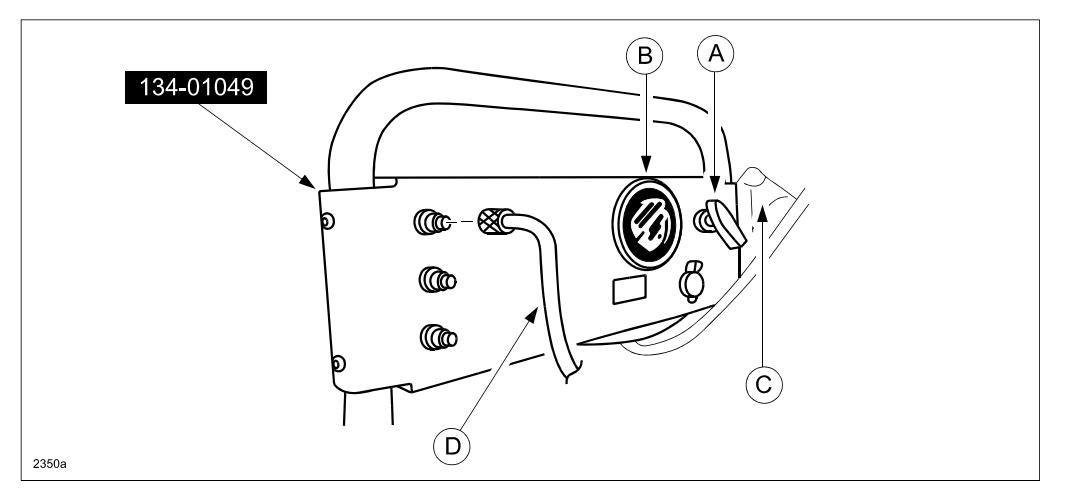
- **NOTE:** For additional information regarding the following procedure, reference the EVAP system leak detection owners manual.
- 1. Calibrate the leak tester for diagnosis.
  - a. Verify that the control valve on the panel is in the HOLD position, then open the nitrogen bottle valve.

- A Control Valve
- B Gauge
- C Flow Meter
- D EVAP Tester Hose
- b. Connect the vehicle interface hose (part of generic adapter) to the SELF-TEST port located on the control panel. Hand tighten the fitting (do not over-tighten).
- c. Turn the control valve to the TEST position (the gauge should read 331 381 mm {13 15 in} of water).
  - **NOTE:** If the gauge is not reading in above range, adjust the pressure by turning the black knob (A) on the low pressure regulator on the nitrogen bottle.

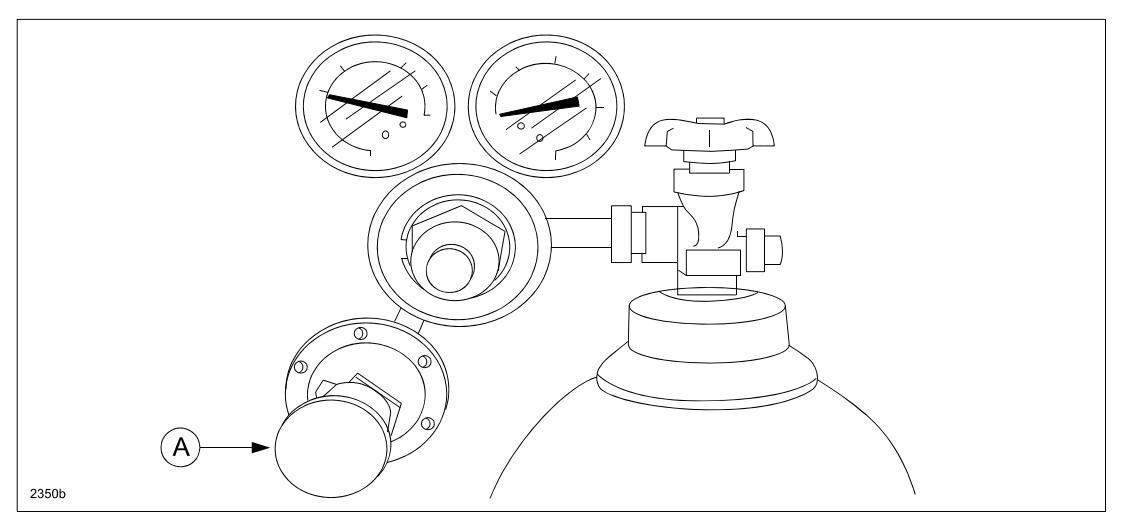
- d. After verifying the regulator is properly calibrated, turn the control valve to the HOLD position.
- e. Verify the gauge holds pressure and the flow meter reads no flow.

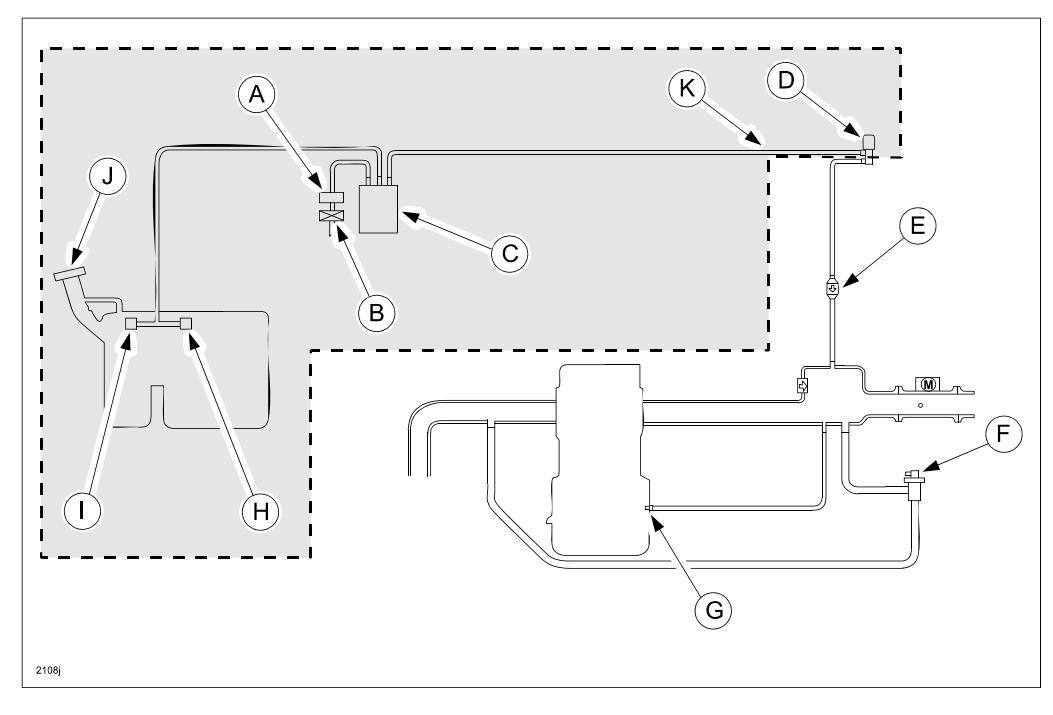
- 2. Disconnect the vacuum tube at or near the purge control valve on the charcoal canister side (shaded area below); Insert the appropriate smoke tester adapter into the vacuum tube at location (K).
  - **NOTE:** If the smoke tester is input using the fuel filler cap adapter (as shown on MS3 online instructions or the Workshop Manual), leakage from the fuel filler cap will not be detected.
  - a. Close the change over valve (COV) using Mode 8.
    - **NOTE:** M-MDS Mode 8 will release the COV after ten (10) minutes. Close the COV again as necessary to finish the inspection.
  - b. Induce smoke into the system.
  - c. Loosen the fuel cap (J) until the smoke starts coming out. Close the fuel cap and inspect the EVAP system for leaks.

A - EVAP System Leak Detection Pump	G - PCV Valve	
B - Air Filter	H - Rollover Valve	
C - Charcoal Canister	I - Fuel Shut-Off Valve	
D - Purge Solenoid Valve	J - Fuel Filler Cap	
E - Check Valve	K - Hook Up SmokeTester (Canister Side)	
F - EGR Valve
